Access Compliance Report

Public Rights-of-Way

(Curb Ramps)

Intersection ID: 50635	Main Street: RED_WATER_RD	Cross Street: BLUE_BLOSSOM_RD	Location:	N
ADA ID: EAD04C5F1267	Ramp Type: Perp	Initial Pass/Fail: Fail	Overall Compliance: No	Severity Score: 10

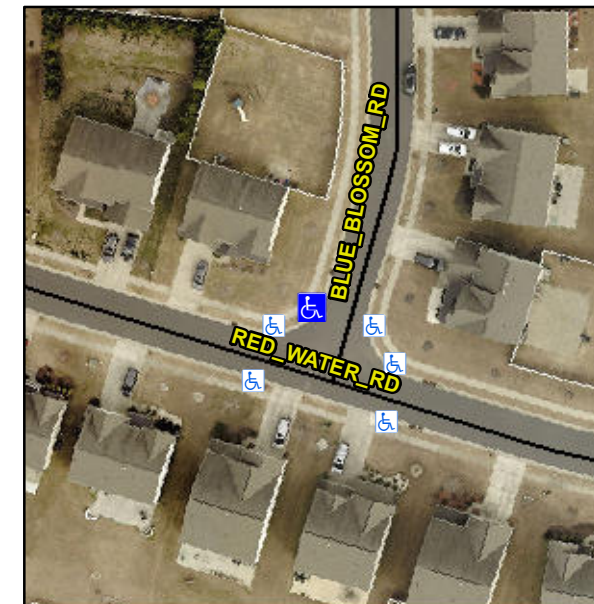
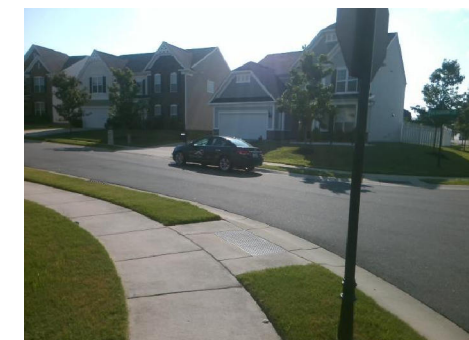
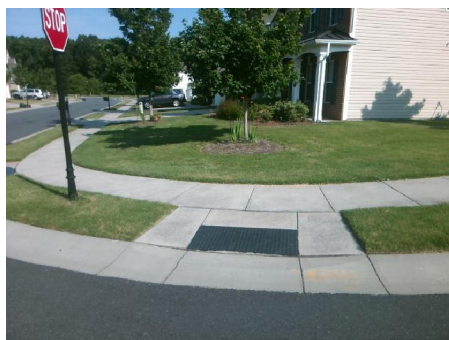
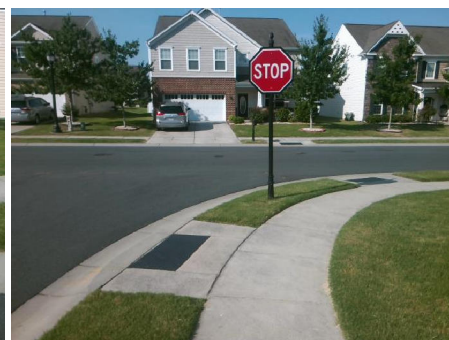
Not Found, R304.5.1, R304.5.3

Compliance	Description	Data	Compliance	Description	Data
N/A	Ramp Length (in)	47.0	Yes	Ramp Slope (%)	5.7
No	Ramp Width (in)	47.0	No	Ramp XSlope (%)	3.0
N/A	Flare Type LT	N/A	N/A	Flare Type RT	N/A
N/A	Flare Slope LT (%)	N/A	N/A	Flare Slope RT (%)	N/A
N/A	Flare Traversable LT?	N/A	N/A	Flare Traversable RT?	N/A
N/A	Landing Length (in)	N/A	N/A	DWS Provided?	N/A
N/A	Landing Width (in)	N/A	N/A	DWS Contrast?	N/A
N/A	Landing Slope (%)	N/A	N/A	DWS Length (in)	N/A
N/A	Landing X Slope (%)	N/A	N/A	DWS Full Width?	N/A
N/A	Landing Curb? (Y/N)	N/A	N/A	DWS Offset (in)	N/A
N/A	Shared Landing?	N/A			
N/A	Gutter Ponding?	N/A	N/A	Gutter Slope (%)	N/A
N/A	Gutter Lip Ht (in)	N/A	N/A	Gutter X Slope (%)	N/A
N/A	Painted X Walk1?	No	N/A	Painted X Walk2?	N/A
	X Walk 1 Direction	To SE		X Walk 2 Direction	N/A
N/A	X Walk 1 Width (in)	N/A	N/A	X Walk 2 Width (in)	N/A
	X Walk 1 Slope (%)	0.7		X Walk 2 Slope (%)	N/A
	X Walk 1 X Slope (%)	2.7		X Walk 2 X Slope (%)	N/A

N/A	Ramp inside XWalk1?	N/A	N/A	Ramp inside XWalk2?	N/A
	Road Slope (%)	N/A	N/A	Clear Space?	N/A
	Road X Slope (%)	N/A	N/A	Clear Space to XWalk (in)	N/A
N/A	Any Obstructions?	N/A	N/A	Storm Grate/Utility Hazard?	N/A
	Obstruction Type			Storm Grate/Utility Type	
		N/A			N/A
			Yes	Surface Condition? (G/P)	Good

Remove & Replace Entire Ramp.

Total Cost: \$ 1850.00
