# Access Compliance Report

## Public Rights-of-Way

### (Curb Ramps)

| Intersection ID: 13760 | Main Street: EUCLID_AV | Cross Street: TEMPLETON_AV | Location: S |

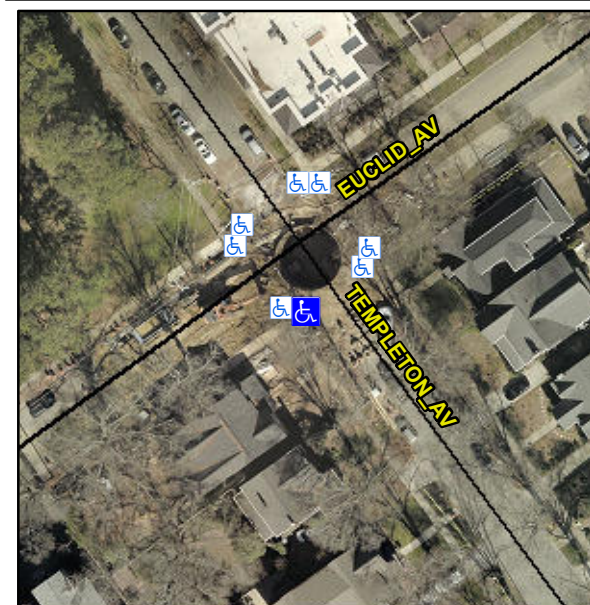
| ADA ID: EAD5C9D77613 | Ramp Type: Directional1 | Initial Pass/Fail: Fail | Overall Compliance: No |
| Severity Score: 31.25 | | | |

**R304.5.1, R304.2.2, R304.5.3**

| Compliance | Description | Data | Compliance | Description | Data |
|---|---|---|---|---|---|
| No | Ramp Width (in) | 32.0 | N/A | Grade Break Slope (%) | 0.0 |
| No | Ramp Slope (%) | 9.1 | N/A | Grade Break XSlope (%) | 0.0 |
| No | Ramp XSlope (%) | 3.1 | | | |

**Remove & Replace Entire Ramp.**

Total Cost: \$ **1600.00**
