Access Compliance Report

Public Rights-of-Way

(Curb Ramps)

| Intersection ID: 15786 | Main Street: N_SHARON_AMITY_RD | Cross Street: AMITY_PL | Location: W |

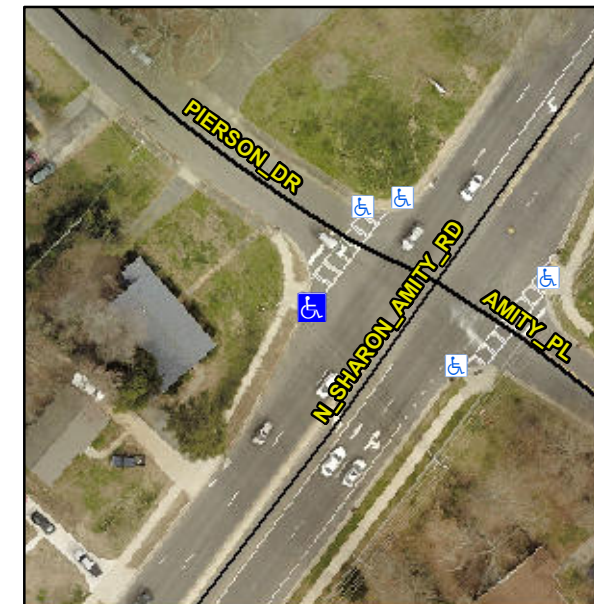
| ADA ID: EADBEA00A88E | Ramp Type: PerpDiag | Initial Pass/Fail: Fail | Overall Compliance: No |

R304.2.2

| Compliance | Description | Data | Compliance | Description | Data |
|---|---|---|---|---|---|
| N/A | Ramp Length (in) | 66.0 | No | Ramp Slope (%) | 9.6 |

Remove & Replace Curb Ramp With Two New Directional Ramps or Equivalent.

\$ 3200.00
