Access Compliance Report

Public Rights-of-Way

(Curb Ramps)

Intersection ID: 47468	Main Street: MILLSTREAM RIDGE DR	Cross Street: ELENDIL LN	Location: NE
ADA ID: EAE1A69998F0	Ramp Type: Perp	Initial Pass/Fail: Fail	Overall Compliance: No
Severity Score: 46.25			
Codes/Mitigation Info/Possible Solution		Field Measurements/Component Compliance

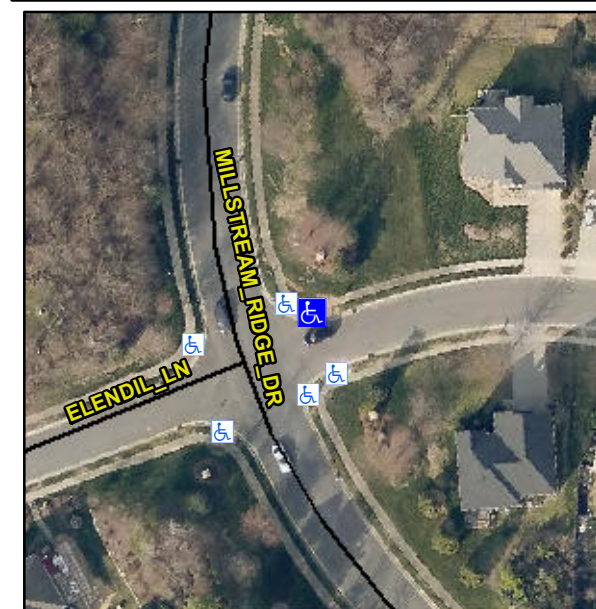
Compliance	Description	Data	Compliance	Description	Data
N/A	Ramp Length (in)	49.0	No	Ramp Slope (%)	11.3
No	Ramp Width (in)	39.0	No	Ramp XSlope (%)	7.5
N/A	Flare Type LT	N/A	N/A	Flare Type RT	N/A
N/A	Flare Slope LT (%)	N/A	N/A	Flare Slope RT (%)	N/A
N/A	Flare Traversable LT?	N/A	N/A	Flare Traversable RT?	N/A
N/A	Landing Length (in)	N/A	N/A	DWS Provided?	N/A
N/A	Landing Width (in)	N/A	N/A	DWS Contrast?	N/A
N/A	Landing Slope (%)	N/A	N/A	DWS Length (in)	N/A
N/A	Landing X Slope (%)	N/A	N/A	DWS Full Width?	N/A
N/A	Landing Curb? (Y/N)	N/A	N/A	DWS Offset (in)	N/A
N/A	Shared Landing?	N/A			
N/A	Gutter Ponding?	N/A	N/A	Gutter Slope (%)	N/A
N/A	Gutter Lip Ht (in)	N/A	N/A	Gutter X Slope (%)	N/A
N/A	Painted X Walk1?	No	N/A	Painted X Walk2?	N/A
	X Walk 1 Direction	To S		X Walk 2 Direction	N/A
N/A	X Walk 1 Width (in)	N/A	N/A	X Walk 2 Width (in)	N/A
	X Walk 1 Slope (%)	8.8		X Walk 2 Slope (%)	N/A
	X Walk 1 X Slope (%)	6.2		X Walk 2 X Slope (%)	N/A

N/A	Ramp inside XWalk1?	N/A	N/A	Ramp inside XWalk2?	N/A
	Road Slope (%)	N/A	N/A	Clear Space?	N/A
	Road X Slope (%)	N/A	N/A	Clear Space to XWalk (in)	N/A
N/A	Any Obstructions?	N/A	N/A	Storm Grate/Utility Hazard?	N/A
	Obstruction Type			Storm Grate/Utility Type	
		N/A			N/A
			Yes	Surface Condition? (G/P)	Good

Possible Solutions:

Remove & Replace Entire Ramp.
