Access Compliance Report

Public Rights-of-Way

(Curb Ramps)

Intersection ID: 13911	Main Street: LEXINGTON_AV	Cross Street: ORIOLE_AV	Location:	N
ADA ID: EAF168FE1C50	Ramp Type: Perp	Initial Pass/Fail: Fail	Overall Compliance: No	Severity Score: 13.75
Codes/Mitigation Info/Possible Solution		Field Measurements/Component Compliance

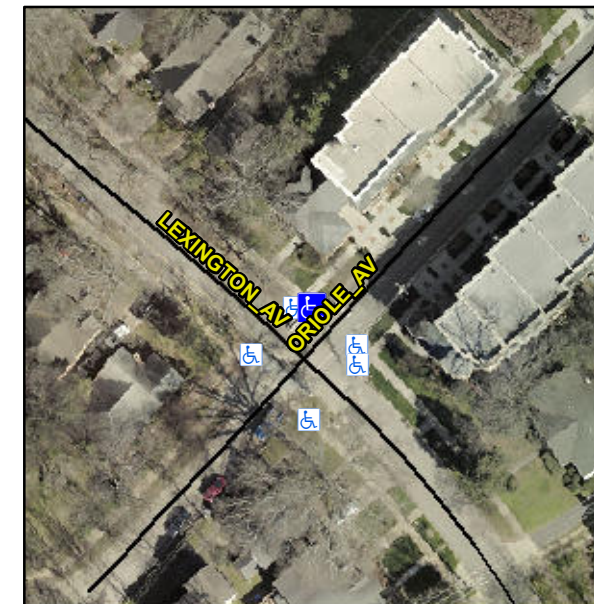
Not Found, R304.2.2, R304.5.3

Compliance	Description	Data	Compliance	Description	Data
N/A	Ramp Length (in)	78.0	No	Ramp Slope (%)	8.7
Yes	Ramp Width (in)	48.0	No	Ramp XSlope (%)	2.4
N/A	Flare Type LT	N/A	N/A	Flare Type RT	N/A
N/A	Flare Slope LT (%)	N/A	N/A	Flare Slope RT (%)	N/A
N/A	Flare Traversable LT?	N/A	N/A	Flare Traversable RT?	N/A
N/A	Landing Length (in)	N/A	N/A	DWS Provided?	N/A
N/A	Landing Width (in)	N/A	N/A	DWS Contrast?	N/A
N/A	Landing Slope (%)	N/A	N/A	DWS Length (in)	N/A
N/A	Landing X Slope (%)	N/A	N/A	DWS Full Width?	N/A
N/A	Landing Curb? (Y/N)	N/A	N/A	DWS Offset (in)	N/A
N/A	Shared Landing?	N/A			
N/A	Gutter Ponding?	N/A	N/A	Gutter Slope (%)	N/A
N/A	Gutter Lip Ht (in)	N/A	N/A	Gutter X Slope (%)	N/A
N/A	Painted X Walk1?	No	N/A	Painted X Walk2?	N/A
	X Walk 1 Direction	To SE		X Walk 2 Direction	N/A
N/A	X Walk 1 Width (in)	N/A	N/A	X Walk 2 Width (in)	N/A
	X Walk 1 Slope (%)	0.7		X Walk 2 Slope (%)	N/A
	X Walk 1 X Slope (%)	1.0		X Walk 2 X Slope (%)	N/A

N/A	Ramp inside XWalk1?	N/A	N/A	Ramp inside XWalk2?	N/A
	Road Slope (%)	N/A	N/A	Clear Space?	N/A
	Road X Slope (%)	N/A	N/A	Clear Space to XWalk (in)	N/A
N/A	Any Obstructions?	N/A	N/A	Storm Grate/Utility Hazard?	N/A
	Obstruction Type			Storm Grate/Utility Type	
		N/A			N/A
			Yes	Surface Condition? (G/P)	Good

Possible Solutions:

Remove & Replace Entire Ramp.

Total Cost: \$ 1850.00
