# Access Compliance Report

## Public Rights-of-Way

Intersection ID: 48493	Main Street: NEWTONMORE_DR	Cross Street: BEREWICK_COMMONS_PY	Location: SE
ADA ID: EAFE030662A7	Ramp Type: PerpDiag	Initial Pass/Fail: Fail	Overall Compliance: No
Severity Score: 8.75			
Codes/Mitigation Info/Possible Solution		Field Measurements/Component Compliance

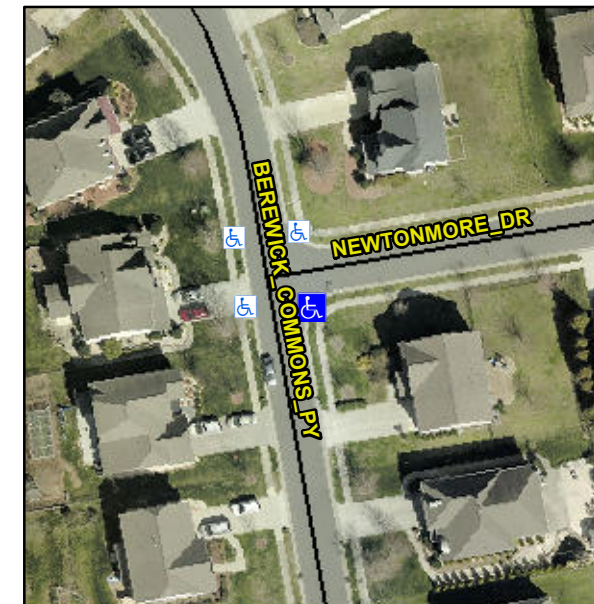
Compliance	Description	Data	Compliance	Description	Data
N/A	Ramp Length (in)	48.0	Yes	Ramp Slope (%)	6.5
No	Ramp Width (in)	44.0	Yes	Ramp XSlope (%)	0.5
N/A	Flare Type LT	N/A	N/A	Flare Type RT	N/A
N/A	Flare Slope LT (%)	N/A	N/A	Flare Slope RT (%)	N/A
N/A	Flare Traversable LT?	N/A	N/A	Flare Traversable RT?	N/A
N/A	Landing Length (in)	N/A	N/A	DWS Provided?	N/A
N/A	Landing Width (in)	N/A	N/A	DWS Contrast?	N/A
N/A	Landing Slope (%)	N/A	N/A	DWS Length (in)	N/A
N/A	Landing X Slope (%)	N/A	N/A	DWS Full Width?	N/A
N/A	Landing Curb? (Y/N)	N/A	N/A	DWS Offset (in)	N/A
N/A	Shared Landing?	N/A			
N/A	Gutter Ponding?	N/A	N/A	Gutter Slope (%)	N/A
N/A	Gutter Lip Ht (in)	N/A	N/A	Gutter X Slope (%)	N/A
N/A	Painted X Walk1?	No	N/A	Painted X Walk2?	No
	X Walk 1 Direction	To N		X Walk 2 Direction	To W
N/A	X Walk 1 Width (in)	N/A	N/A	X Walk 2 Width (in)	N/A
	X Walk 1 Slope (%)	3.5		X Walk 2 Slope (%)	2.6
	X Walk 1 X Slope (%)	0.1		X Walk 2 X Slope (%)	3.6

N/A	Ramp inside XWalk1?	N/A	N/A	Ramp inside XWalk2?	N/A
	Road Slope (%)	1.9	N/A	Clear Space?	N/A
	Road X Slope (%)	3.6	N/A	Clear Space to XWalk (in)	N/A
N/A	Any Obstructions?	N/A	N/A	Storm Grate/Utility Hazard?	N/A
	Obstruction Type			Storm Grate/Utility Type	
		N/A			N/A
		Yes		Surface Condition? (G/P)	Good

**Remove & Replace Curb Ramp With Two New Directional Ramps or Equivalent.**

**Not Found, R304.5.1**
