# Access Compliance Report

## Public Rights-of-Way

### (Curb Ramps)

Intersection ID: 3299	Main Street: BRANTHURST_DR	Cross Street: SPRING_PARK_DR	Location: W
ADA ID: EB10B6D9683A	Ramp Type: Perp	Initial Pass/Fail: Fail	Overall Compliance: No
Severity Score: 30			
Codes/Mitigation Info/Possible Solution		Field Measurements/Component Compliance

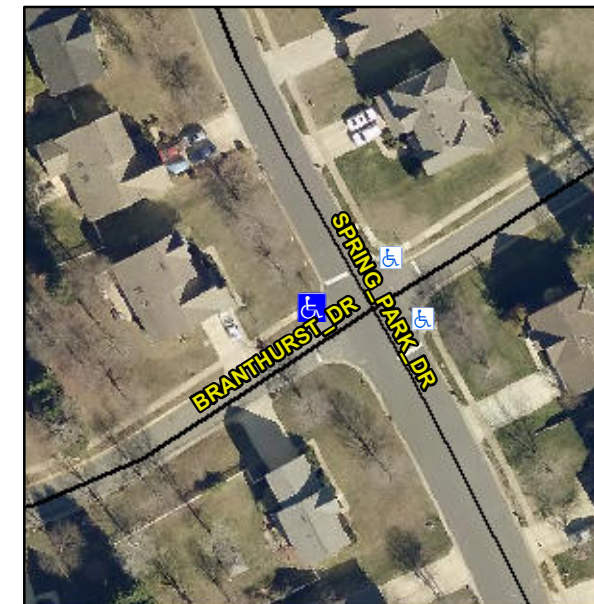
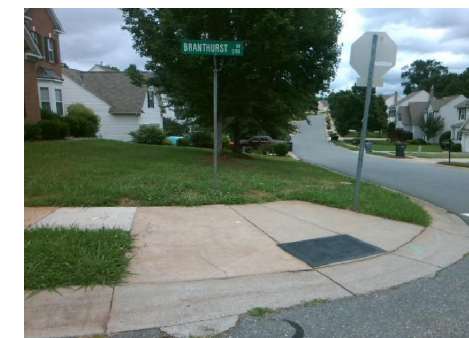
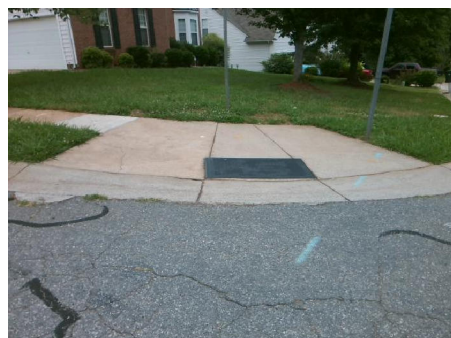
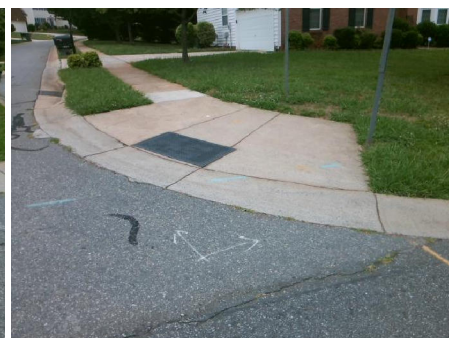
Compliance	Description	Data	Compliance	Description	Data
N/A	Ramp Length (in)	96.0	Yes	Ramp Slope (%)	6.2
No	Ramp Width (in)	35.0	No	Ramp XSlope (%)	6.6
N/A	Flare Type LT	N/A	N/A	Flare Type RT	N/A
N/A	Flare Slope LT (%)	N/A	N/A	Flare Slope RT (%)	N/A
N/A	Flare Traversable LT?	N/A	N/A	Flare Traversable RT?	N/A
N/A	Landing Length (in)	N/A	N/A	DWS Provided?	N/A
N/A	Landing Width (in)	N/A	N/A	DWS Contrast?	N/A
N/A	Landing Slope (%)	N/A	N/A	DWS Length (in)	N/A
N/A	Landing X Slope (%)	N/A	N/A	DWS Full Width?	N/A
N/A	Landing Curb? (Y/N)	N/A	N/A	DWS Offset (in)	N/A
N/A	Shared Landing?	N/A			
N/A	Gutter Ponding?	N/A	N/A	Gutter Slope (%)	N/A
N/A	Gutter Lip Ht (in)	N/A	N/A	Gutter X Slope (%)	N/A
N/A	Painted X Walk1?	No	N/A	Painted X Walk2?	N/A
	X Walk 1 Direction	To NE		X Walk 2 Direction	N/A
N/A	X Walk 1 Width (in)	N/A	N/A	X Walk 2 Width (in)	N/A
	X Walk 1 Slope (%)	4.9		X Walk 2 Slope (%)	N/A
	X Walk 1 X Slope (%)	3.1		X Walk 2 X Slope (%)	N/A

N/A	Ramp inside XWalk1?	N/A	N/A	Ramp inside XWalk2?	N/A
	Road Slope (%)	N/A	N/A	Clear Space?	N/A
	Road X Slope (%)	N/A	N/A	Clear Space to XWalk (in)	N/A
N/A	Any Obstructions?	N/A	N/A	Storm Grate/Utility Hazard?	N/A
	Obstruction Type			Storm Grate/Utility Type	
		N/A			N/A
			Yes	Surface Condition? (G/P)	Good

**Remove & Replace Entire Ramp.**

**R304.5.1, R304.5.3**
