## **Access Compliance Report Public Rights-of-Way** (Curb Ramps)

Intersection ID: 47775 Main Street: BEREWICK\_COMMONS\_PKY Cross Street: TRAILMOOR\_RD Location: NE

ADA ID: EB1C8360827E Ramp Type: PerpDiag Initial Pass/Fail: Fail **Overall Compliance: No** Severity Score: 13.75

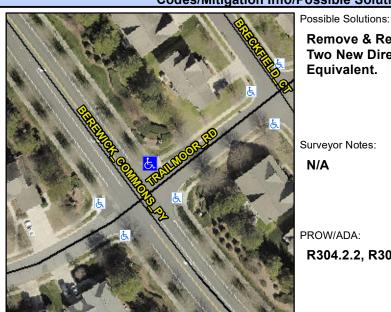
Comp	liance Description	Data	Comp	liance	Description	Data
N/A	Ramp Length (in)	52.0	No	No Ramp Slope (%)		11.0
Yes	Ramp Width (in)	48.0	No	Ramp	Ramp XSlope (%)	
N/A	Flare Type LT	N/A	N/A	Flare	Type RT	N/A
N/A	Flare Slope LT (%)	N/A	N/A	Flare	Slope RT (%)	N/A
N/A	Flare Traversable LT?	N/A	N/A	Flare	Traversable RT?	N/A
N/A	Landing Length (in)	N/A	N/A	DWS	Provided?	N/A
N/A	Landing Width (in)	N/A	N/A	DWS	Contrast?	N/A
N/A	Landing Slope (%)	N/A	N/A	DWS	Length (in)	N/A
N/A	Landing X Slope (%)	N/A	N/A	DWS	Full Width?	N/A
N/A	Landing Curb? (Y/N)	N/A	N/A	DWS	Offset (in)	N/A
N/A	Shared Landing?	N/A				
N/A	Gutter Ponding?	N/A	N/A	Gutte	r Slope (%)	N/A
N/A	Gutter Lip Ht (in)	N/A	N/A	Gutte	r X Slope (%)	N/A
N/A	Painted X Walk1?	No	N/A	Paint	ed X Walk2?	No
	X Walk 1 Direction	To SW		X Wa	lk 2 Direction	To SE
N/A	X Walk 1 Width (in)	N/A	N/A	X Wa	lk 2 Width (in)	N/A
	X Walk 1 Slope (%)	0.1		X Wa	lk 2 Slope (%)	0.9
	X Walk 1 X Slope (%)	0.2		X Wa	lk 2 X Slope (%)	0.7

Remove & Replace Curb Ramp With Two New Directional Ramps or Equivalent.

R304.2.2, R304.5.3
