Access Compliance Report

Public Rights-of-Way

(Curb Ramps)

Intersection ID: 18571	Main Street: BECKHAM_CT	Cross Street: RANDOLPH_RD	Location: NW
ADA ID: EB20C7C55172	Ramp Type: PerpDiag	Initial Pass/Fail: Fail	Overall Compliance: No
Codes/Mitigation Info/Possible Solution		Field Measurements/Component Compliance

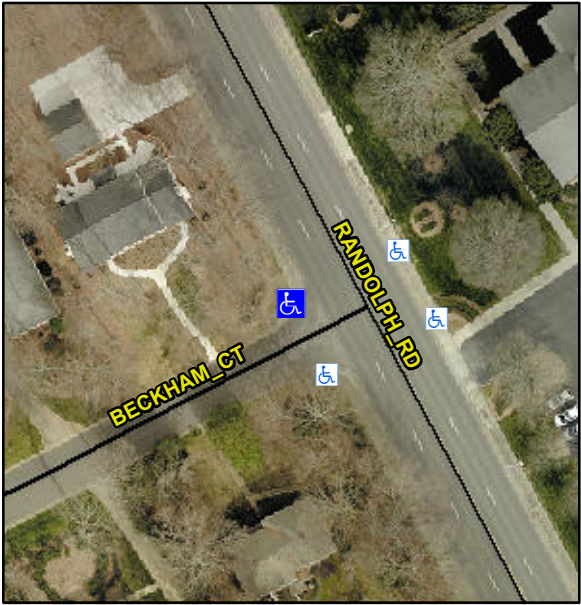
Possible Solutions:	Compliance	Description	Data	Compliance	Description	Data
	Remove & Replace Curb Ramp With Two New Directional Ramps or Equivalent.	N/A	Ramp Length (in)	71.0	No	Ramp Slope (%)	10.6
<p>Surveyor Notes:</p> <p>N/A</p> <p>PROW/ADA:</p> <p>Not Found, R304.5.1, R304.2.2</p>		No	Ramp Width (in)	46.0	Yes	Ramp XSlope (%)	0.5
		N/A	Flare Type LT	N/A	N/A	Flare Type RT	N/A
<p>Street 1 Name</p> <p>BECKHAM CT</p> <p>Stop Condition-Street 2</p> <p>StopSign</p> <p>Street 2 Name</p> <p>RANDOLPH RD</p> <p>Stop Condition-Street 1</p> <p>None</p>		N/A	Flare Slope LT (%)	N/A	N/A	Flare Slope RT (%)	N/A
		N/A	Flare Traversable LT?	N/A	N/A	Flare Traversable RT?	N/A
<p>Total Cost:</p> <p>\$ 3200.00</p>		N/A	Landing Length (in)	N/A	N/A	DWS Provided?	N/A
		N/A	Landing Width (in)	N/A	N/A	DWS Contrast?	N/A
		N/A	Landing Slope (%)	N/A	N/A	DWS Length (in)	N/A
		N/A	Landing X Slope (%)	N/A	N/A	DWS Full Width?	N/A

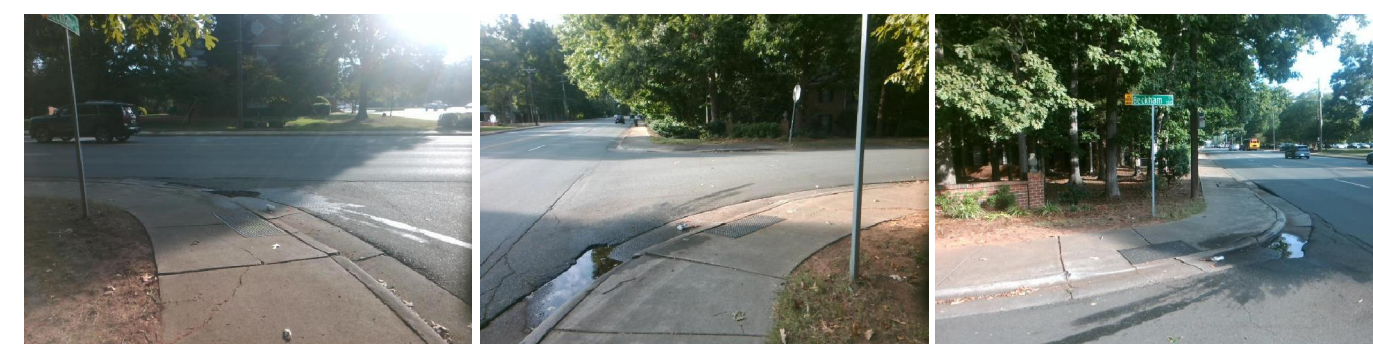
N/A	Landing Curb? (Y/N)	N/A	N/A	DWS Offset (in)	N/A
		N/A	Shared Landing?	N/A			
		N/A	Gutter Ponding?	N/A	N/A	Gutter Slope (%)	N/A
		N/A	Gutter Lip Ht (in)	N/A	N/A	Gutter X Slope (%)	N/A
		N/A	Painted X Walk1?	No	N/A	Painted X Walk2?	No
			X Walk 1 Direction	To S		X Walk 2 Direction	To E
		N/A	X Walk 1 Width (in)	N/A	N/A	X Walk 2 Width (in)	N/A
			X Walk 1 Slope (%)	0.7		X Walk 2 Slope (%)	1.1
			X Walk 1 X Slope (%)	0.2		X Walk 2 X Slope (%)	3.1
		N/A	Ramp inside XWalk1?	N/A	N/A	Ramp inside XWalk2?	N/A
			Road Slope (%)	0.8	N/A	Clear Space?	N/A
			Road X Slope (%)	0.7	N/A	Clear Space to XWalk (in)	N/A
		N/A	Any Obstructions?	N/A	N/A	Storm Grate/Utility Hazard?	N/A
			Obstruction Type			Storm Grate/Utility Type	
					N/A		N/A
					Yes	Surface Condition? (G/P)	Good
