Access Compliance Report

Public Rights-of-Way

(Curb Ramps)

Intersection ID: 15397	Main Street: N_WENDOVER_RD	Cross Street: N_WENDOVER_RD_RA	Location:	N
ADA ID: EB3055398B88	Ramp Type: Perp	Initial Pass/Fail: Fail	Overall Compliance: No	Severity Score: 12.5
Codes/Mitigation Info/Possible Solution		Field Measurements/Component Compliance

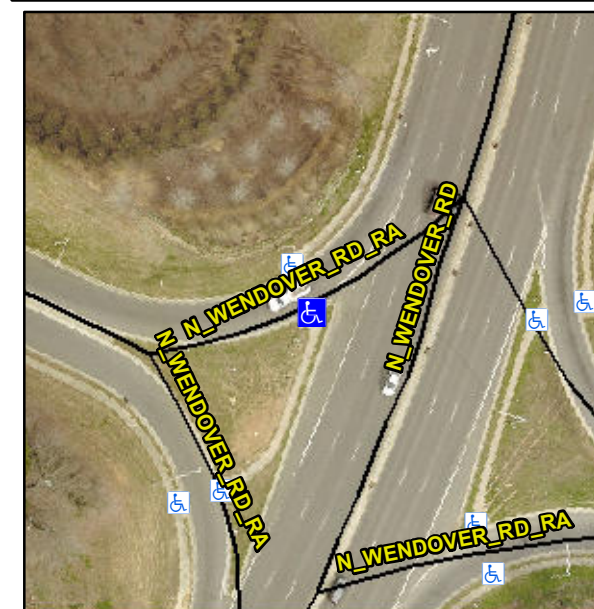
Not Found, R304.2.2

Compliance	Description	Data	Compliance	Description	Data
N/A	Ramp Length (in)	94.0	No	Ramp Slope (%)	9.9
Yes	Ramp Width (in)	56.5	Yes	Ramp XSlope (%)	1.6
N/A	Flare Type LT	N/A	N/A	Flare Type RT	N/A
N/A	Flare Slope LT (%)	N/A	N/A	Flare Slope RT (%)	N/A
N/A	Flare Traversable LT?	N/A	N/A	Flare Traversable RT?	N/A
N/A	Landing Length (in)	N/A	N/A	DWS Provided?	N/A
N/A	Landing Width (in)	N/A	N/A	DWS Contrast?	N/A
N/A	Landing Slope (%)	N/A	N/A	DWS Length (in)	N/A
N/A	Landing X Slope (%)	N/A	N/A	DWS Full Width?	N/A
N/A	Landing Curb? (Y/N)	N/A	N/A	DWS Offset (in)	N/A
N/A	Shared Landing?	N/A			
N/A	Gutter Ponding?	N/A	N/A	Gutter Slope (%)	N/A
N/A	Gutter Lip Ht (in)	N/A	N/A	Gutter X Slope (%)	N/A
N/A	Painted X Walk1?	No	N/A	Painted X Walk2?	N/A
	X Walk 1 Direction	To NW		X Walk 2 Direction	N/A
N/A	X Walk 1 Width (in)	N/A	N/A	X Walk 2 Width (in)	N/A
	X Walk 1 Slope (%)	6.0		X Walk 2 Slope (%)	N/A
	X Walk 1 X Slope (%)	2.9		X Walk 2 X Slope (%)	N/A

N/A	Ramp inside XWalk1?	N/A	N/A	Ramp inside XWalk2?	N/A
	Road Slope (%)	N/A	N/A	Clear Space?	N/A
	Road X Slope (%)	N/A	N/A	Clear Space to XWalk (in)	N/A
N/A	Any Obstructions?	N/A	N/A	Storm Grate/Utility Hazard?	N/A
	Obstruction Type			Storm Grate/Utility Type	
		N/A			N/A
			Yes	Surface Condition? (G/P)	Good

Possible Solutions:

Remove & Replace Entire Ramp.

Total Cost: \$ 1850.00
