Access Compliance Report Public Rights-of-Way (Curb Ramps)

Intersection ID: 18755 Main Street: MATADOR_LN Cross Street: SELWYN_AV Location: **Overall Compliance: No Severity Score: ADA ID: EB3624F321BD** Ramp Type: Para Initial Pass/Fail: Fail 1.25

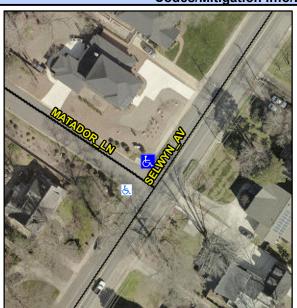
Possible Solutions: Remove & Replace Entire Ramp. Surveyor Notes: **RT RP < 5%** PROW/ADA: R304.5.3

Field Measurements/Component Compliance Compliance Description Data Compliance Description					
N/A	Ramp Length LT (in)	70.5	N/A	Ramp Length RT (in)	<u>Data</u> 38.0
Yes	Ramp Width LT (in)	60.0	Yes	Ramp Width RT (in)	60.0
Yes	Ramp Slope LT (%)	7.4	Yes	Ramp Slope RT (%)	3.5
No	Ramp XSlope LT (%)	2.4	Yes	Ramp XSlope RT (%)	2.0
N/A	Landing Length (in)	N/A	N/A	DWS Provided?	N/A
N/A N/A	Landing Length (in) Landing Width (in)	N/A N/A	N/A	DWS Contrast?	N/A N/A
N/A	Landing Slope (%)	N/A	N/A	DWS Length (in)	N/A
N/A	Landing Slope (%)	N/A N/A	N/A	DWS Full Width?	N/A N/A
N/A N/A	• ,				
	Landing Curb? (Y/N)	N/A	N/A	DWS Offset (in)	N/A
N/A	Shared Landing?	N/A	NI/A	Otan Olana (0/)	NI/A
N/A	Gutter Ponding?	N/A	N/A	Gutter Slope (%)	N/A
N/A	Gutter Lip Ht (in)	N/A	N/A	Gutter X Slope (%)	N/A
N/A	Painted X Walk1?	No	N/A	Painted X Walk2?	N/A
	X Walk 1 Direction	To SW		X Walk 2 Direction	N/A
N/A	X Walk 1 Width (in)	N/A	N/A	X Walk 2 Width (in)	N/A
