## **Access Compliance Report Public Rights-of-Way** (Curb Ramps)

Intersection ID: 43227 Main Street: N\_I-77\_EXIT\_5\_RA Cross Street: N I-77 HY Location: SE **Overall Compliance: No** ADA ID: EB3BA30C48D2 Ramp Type: Perp Initial Pass/Fail: Fail **Severity Score:** 8.75

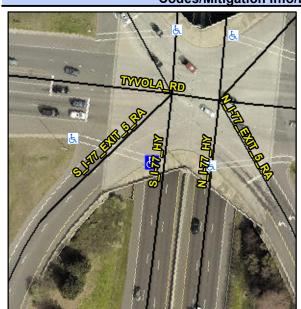
Field Measurements/Component Compnance					
Compliance Description		Data	Compliance Description		Data
N/A	Ramp Length (in)	87.0	Yes	Ramp Slope (%)	5.4
No	Ramp Width (in)	36.0	Yes	Ramp XSlope (%)	1.7
N/A	Flare Type LT	N/A	N/A	Flare Type RT	N/A
N/A	Flare Slope LT (%)	N/A	N/A	Flare Slope RT (%)	N/A
N/A	Flare Traversable LT?	N/A	N/A	Flare Traversable RT?	N/A
N/A	Landing Length (in)	N/A	N/A	DWS Provided?	N/A
N/A	Landing Width (in)	N/A	N/A	DWS Contrast?	N/A
N/A	Landing Slope (%)	N/A	N/A	DWS Length (in)	N/A
N/A	Landing X Slope (%)	N/A	N/A	DWS Full Width?	N/A
N/A	Landing Curb? (Y/N)	N/A	N/A	DWS Offset (in)	N/A
N/A	Shared Landing?	N/A			
N/A	Gutter Ponding?	N/A	N/A	Gutter Slope (%)	N/A
N/A	Gutter Lip Ht (in)	N/A	N/A	Gutter X Slope (%)	N/A
N/A	Painted X Walk1?	Yes	N/A	Painted X Walk2?	N/A
	X Walk 1 Direction	To NW		X Walk 2 Direction	N/A
N/A	X Walk 1 Width (in)	74.0	N/A	X Walk 2 Width (in)	N/A
	X Walk 1 Slope (%)	2.9		X Walk 2 Slope (%)	N/A

X Walk 1 X Slope (%)	2.6		X Walk 2 X Slope (%)	N/A
N/A	Ramp inside XWalk1?	Yes	N/A	Ramp inside XWalk2?	N/A
	Road Slope (%)	N/A	N/A	Clear Space?	N/A
	Road X Slope (%)	N/A	N/A	Clear Space to XWalk (in)	N/A
N/A	Any Obstructions?	N/A	N/A	Storm Grate/Utility Hazard?	N/A
	Obstruction Type		l	Storm Grate/Utility Type	
		N/A			N/A
			Yes	Surface Condition? (G/P)	Good

Possible Solutions: Remove & Replace Entire Ramp. Surveyor Notes: N/A PROW/ADA: R304.5.1
