# Access Compliance Report

## Public Rights-of-Way

### (Curb Ramps)

Intersection ID: 43362	Main Street: PROSPERITY_VIEW_DR	Cross Street: RIDGE_RD	Location: NW
ADA ID: EB414DF88C54	Ramp Type: Perp	Initial Pass/Fail: Fail	Overall Compliance: No
Codes/Mitigation Info/Possible Solution		Field Measurements/Component Compliance	
Severity Score: 8.75

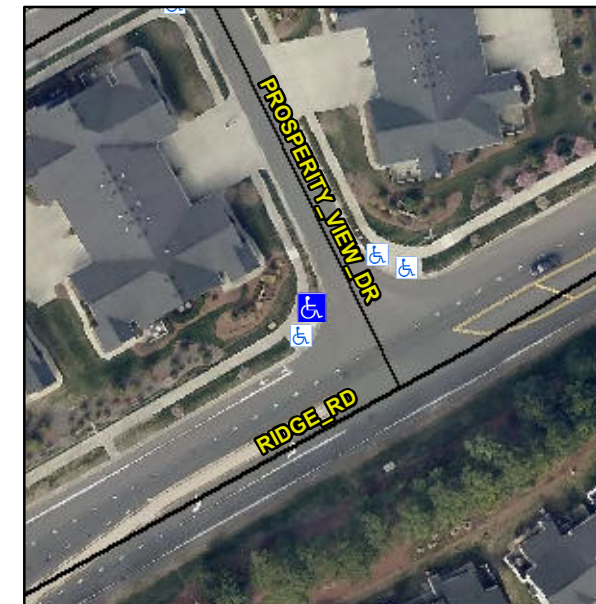
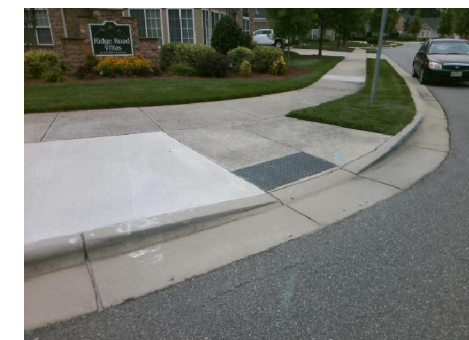
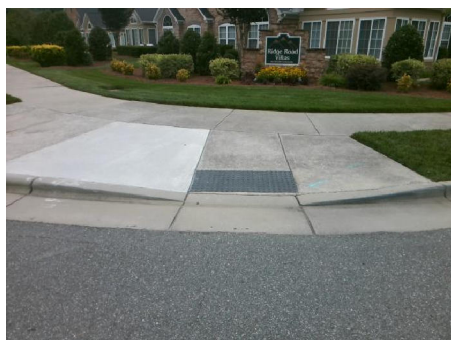
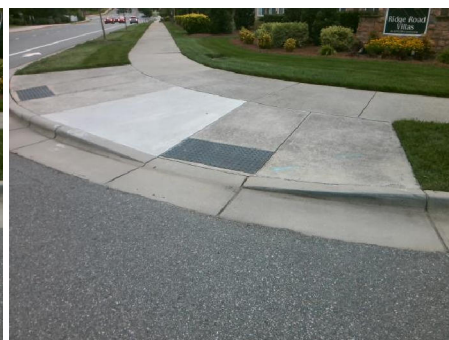
Compliance	Description	Data	Compliance	Description	Data
N/A	Ramp Length (in)	90.0	Yes	Ramp Slope (%)	5.1
No	Ramp Width (in)	46.0	Yes	Ramp XSlope (%)	0.2
N/A	Flare Type LT	N/A	N/A	Flare Type RT	N/A
N/A	Flare Slope LT (%)	N/A	N/A	Flare Slope RT (%)	N/A
N/A	Flare Traversable LT?	N/A	N/A	Flare Traversable RT?	N/A
N/A	Landing Length (in)	N/A	N/A	DWS Provided?	N/A
N/A	Landing Width (in)	N/A	N/A	DWS Contrast?	N/A
N/A	Landing Slope (%)	N/A	N/A	DWS Length (in)	N/A
N/A	Landing X Slope (%)	N/A	N/A	DWS Full Width?	N/A
N/A	Landing Curb? (Y/N)	N/A	N/A	DWS Offset (in)	N/A
N/A	Shared Landing?	N/A			
N/A	Gutter Ponding?	N/A	N/A	Gutter Slope (%)	N/A
N/A	Gutter Lip Ht (in)	N/A	N/A	Gutter X Slope (%)	N/A
N/A	Painted X Walk1?	No	N/A	Painted X Walk2?	N/A
	X Walk 1 Direction	To E		X Walk 2 Direction	N/A
N/A	X Walk 1 Width (in)	N/A	N/A	X Walk 2 Width (in)	N/A
	X Walk 1 Slope (%)	2.6		X Walk 2 Slope (%)	N/A
	X Walk 1 X Slope (%)	0.3		X Walk 2 X Slope (%)	N/A

N/A	Ramp inside XWalk1?	N/A	N/A	Ramp inside XWalk2?	N/A
	Road Slope (%)	N/A	N/A	Clear Space?	N/A
	Road X Slope (%)	N/A	N/A	Clear Space to XWalk (in)	N/A
N/A	Any Obstructions?	N/A	N/A	Storm Grate/Utility Hazard?	N/A
	Obstruction Type			Storm Grate/Utility Type	
		N/A			N/A
			Yes	Surface Condition? (G/P)	Good

**Remove & Replace Entire Ramp.**

**R304.5.1**
