Access Compliance Report

Public Rights-of-Way

(Curb Ramps)

Intersection ID: 25142	Main Street: COTTON_CREEK_DR	Cross Street: WEAVER_MILL_LN	Location: E
ADA ID: EB4479C8D811	Ramp Type: PerpDiag	Initial Pass/Fail: Fail	Overall Compliance: No
Severity Score: 21.25			
Codes/Mitigation Info/Possible Solution		Field Measurements/Component Compliance

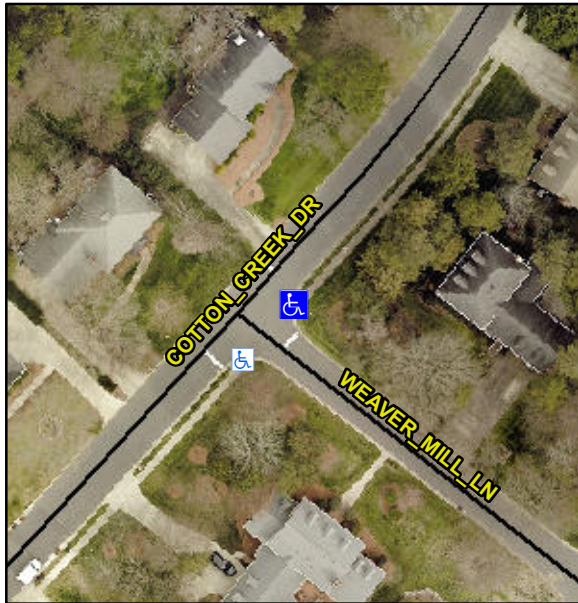
Compliance	Description	Data	Compliance	Description	Data
N/A	Ramp Length (in)	48.0	No	Ramp Slope (%)	10.5
No	Ramp Width (in)	36.0	Yes	Ramp XSlope (%)	1.7
N/A	Flare Type LT	N/A	N/A	Flare Type RT	N/A
N/A	Flare Slope LT (%)	N/A	N/A	Flare Slope RT (%)	N/A
N/A	Flare Traversable LT?	N/A	N/A	Flare Traversable RT?	N/A
N/A	Landing Length (in)	N/A	N/A	DWS Provided?	N/A
N/A	Landing Width (in)	N/A	N/A	DWS Contrast?	N/A
N/A	Landing Slope (%)	N/A	N/A	DWS Length (in)	N/A
N/A	Landing X Slope (%)	N/A	N/A	DWS Full Width?	N/A
N/A	Landing Curb? (Y/N)	N/A	N/A	DWS Offset (in)	N/A
N/A	Shared Landing?	N/A			
N/A	Gutter Ponding?	N/A	N/A	Gutter Slope (%)	N/A
N/A	Gutter Lip Ht (in)	N/A	N/A	Gutter X Slope (%)	N/A
N/A	Painted X Walk1?	No	N/A	Painted X Walk2?	No
	X Walk 1 Direction	To NW		X Walk 2 Direction	To SW
N/A	X Walk 1 Width (in)	N/A	N/A	X Walk 2 Width (in)	N/A
	X Walk 1 Slope (%)	5.0		X Walk 2 Slope (%)	1.1
	X Walk 1 X Slope (%)	0.2		X Walk 2 X Slope (%)	6.1

N/A	Ramp inside XWalk1?	N/A	N/A	Ramp inside XWalk2?	N/A
	Road Slope (%)	4.9	N/A	Clear Space?	N/A
	Road X Slope (%)	4.8	N/A	Clear Space to XWalk (in)	N/A
N/A	Any Obstructions?	N/A	N/A	Storm Grate/Utility Hazard?	N/A
	Obstruction Type			Storm Grate/Utility Type	
		N/A			N/A
		Yes		Surface Condition? (G/P)	Good

Possible Solutions:

Remove & Replace Curb Ramp With Two New Directional Ramps or Equivalent.
