# Access Compliance Report

## Public Rights-of-Way

### (Curb Ramps)

Intersection ID: 52926	Main Street: WALTHAM_LN	Cross Street: EMORY_OAK_DR	Location: E
ADA ID: EB48737C7B76	Ramp Type: Perp	Initial Pass/Fail: Fail	Overall Compliance: No
		Severity Score: 30

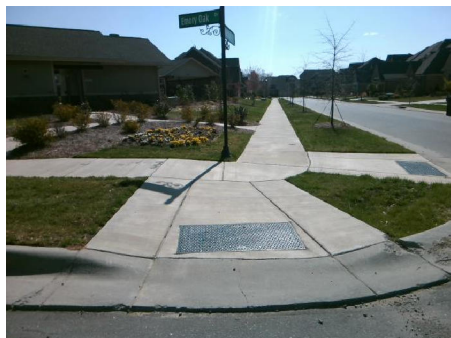
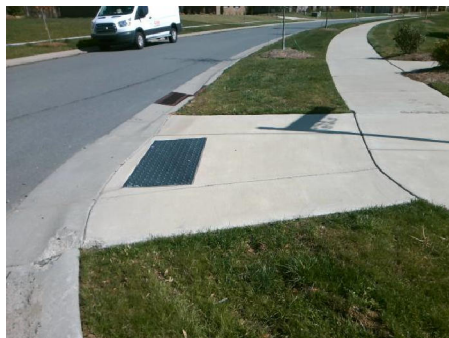
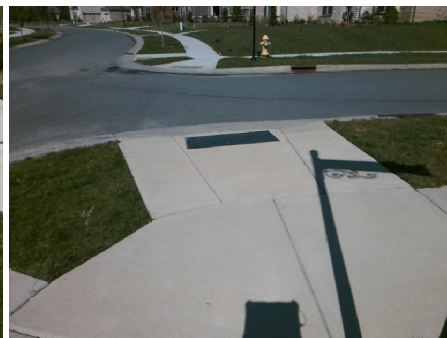
**Not Found, R304.5.1, R304.5.3**

Compliance	Description	Data	Compliance	Description	Data
N/A	Ramp Length (in)	95.5	Yes	Ramp Slope (%)	5.7
No	Ramp Width (in)	34.0	No	Ramp XSlope (%)	6.2
N/A	Flare Type LT	N/A	N/A	Flare Type RT	N/A
N/A	Flare Slope LT (%)	N/A	N/A	Flare Slope RT (%)	N/A
N/A	Flare Traversable LT?	N/A	N/A	Flare Traversable RT?	N/A
N/A	Landing Length (in)	N/A	N/A	DWS Provided?	N/A
N/A	Landing Width (in)	N/A	N/A	DWS Contrast?	N/A
N/A	Landing Slope (%)	N/A	N/A	DWS Length (in)	N/A
N/A	Landing X Slope (%)	N/A	N/A	DWS Full Width?	N/A
N/A	Landing Curb? (Y/N)	N/A	N/A	DWS Offset (in)	N/A
N/A	Shared Landing?	N/A			
N/A	Gutter Ponding?	N/A	N/A	Gutter Slope (%)	N/A
N/A	Gutter Lip Ht (in)	N/A	N/A	Gutter X Slope (%)	N/A
N/A	Painted X Walk1?	No	N/A	Painted X Walk2?	N/A
	X Walk 1 Direction	To NW		X Walk 2 Direction	N/A
N/A	X Walk 1 Width (in)	N/A	N/A	X Walk 2 Width (in)	N/A
	X Walk 1 Slope (%)	3.9		X Walk 2 Slope (%)	N/A
	X Walk 1 X Slope (%)	2.6		X Walk 2 X Slope (%)	N/A

N/A	Ramp inside XWalk1?	N/A	N/A	Ramp inside XWalk2?	N/A
	Road Slope (%)	N/A	N/A	Clear Space?	N/A
	Road X Slope (%)	N/A	N/A	Clear Space to XWalk (in)	N/A
N/A	Any Obstructions?	N/A	N/A	Storm Grate/Utility Hazard?	N/A
	Obstruction Type			Storm Grate/Utility Type	
		N/A			N/A
			Yes	Surface Condition? (G/P)	Good

**Remove & Replace Entire Ramp.**

Total Cost: \$ **1850.00**
