# Access Compliance Report

## Public Rights-of-Way

### (Curb Ramps)

Intersection ID: N/A	Main Street: POTOMAC_RIVER_PY	Cross Street: NATIONAL_AV	Location: SE
ADA ID: EB6BB069CD0E	Ramp Type: Directional1	Initial Pass/Fail: Fail	Overall Compliance: No
Codes/Mitigation Info/Possible Solution		Field Measurements/Component Compliance	
Severity Score: 25

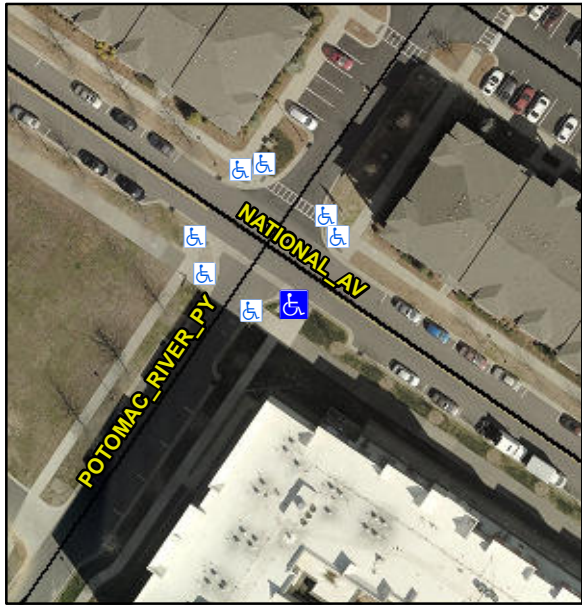
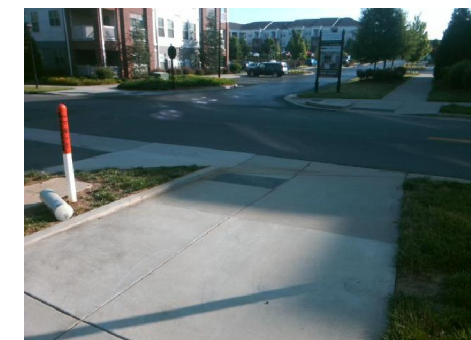
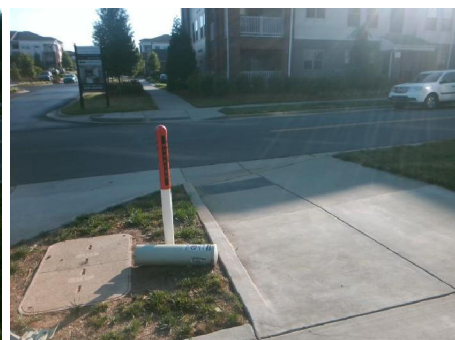
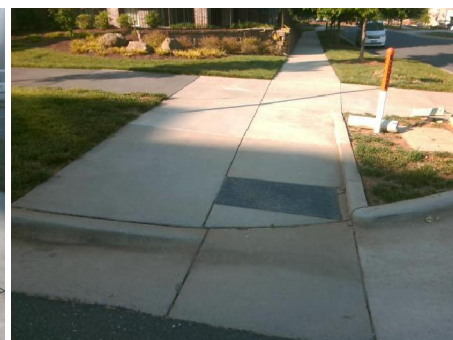
Compliance	Description	Data	Compliance	Description	Data
N/A	Ramp Length (in)	76.0	N/A	Grade Break?	N/A
Yes	Ramp Width (in)	52.5	N/A	Grade Break Slope (%)	0.0
Yes	Ramp Slope (%)	5.8	N/A	Grade Break XSlope (%)	0.0
No	Ramp XSlope (%)	7.5			
N/A	Flare Type LT	N/A	N/A	Flare Type RT	N/A
N/A	Flare Slope LT (%)	N/A	N/A	Flare Slope RT (%)	0.0
N/A	Flare Traversable LT?	N/A	N/A	Flare Traversable RT?	N/A
N/A	Landing Length (in)	0.0	N/A	DWS Provided?	N/A
N/A	Landing Width (in)	0.0	N/A	DWS Contrast?	N/A
N/A	Landing Slope (%)	0.0	N/A	DWS Length (in)	N/A
N/A	Landing X Slope (%)	0.0	N/A	DWS Full Width?	N/A
N/A	Landing Curb? (Y/N)	N/A	N/A	DWS Offset LT (in)	N/A
N/A	Shared Landing?	N/A	N/A	DWS Offset RT (in)	N/A
N/A	Gutter Ponding?	0.0	N/A	Gutter Slope (%)	N/A
N/A	Gutter Lip Ht (in)	0.0	N/A	Gutter X Slope (%)	N/A
N/A	Painted X Walk1?	No		Road Slope (%)	5.1
	X Walk 1 Direction	To N		Road X Slope (%)	2.8
	X Walk 1 Width (in)	N/A		Clear Space?	N/A

X Walk 1 Slope (%)	5.1	N/A	Clear Space to XWalk (in)	N/A
	X Walk 1 X Slope (%)	2.8	N/A	Storm Grate/Utility Hazard?	N/A
N/A	Ramp inside XWalk1?	N/A		Storm Grate/Utility Type	
N/A	Any Obstructions?	N/A			N/A
	Obstruction Type		Yes	Surface Condition? (G/P)	Good
		N/A	N/A	Curb Slope (%)	3.3

Possible Solutions:

Remove & Replace Entire Ramp.

R304.5.3
