# Access Compliance Report

## Public Rights-of-Way

### (Curb Ramps)

Intersection ID: 30311	Main Street: EUROSTAR_DR	Cross Street: ROCKET_LN	Location: S
ADA ID: EB95267A6D1C	Ramp Type: PerpDiag	Initial Pass/Fail: Fail	Overall Compliance: No
		Severity Score: 10

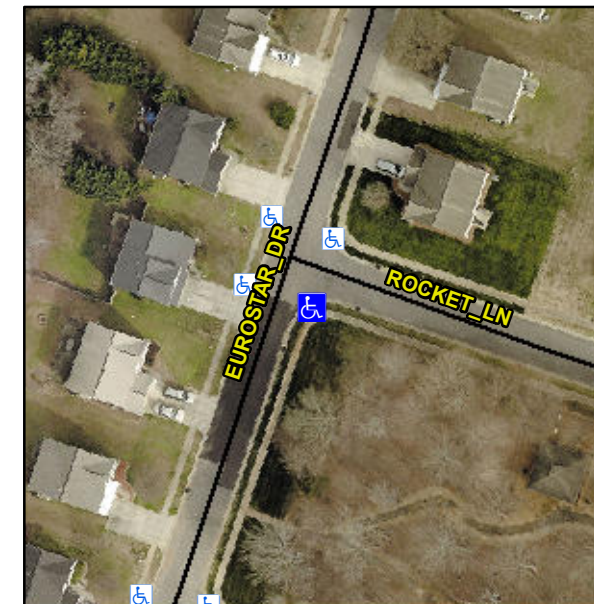
**Not Found, R304.5.1, R304.5.3**

Compliance	Description	Data	Compliance	Description	Data
N/A	Ramp Length (in)	46.0	Yes	Ramp Slope (%)	8.1
No	Ramp Width (in)	41.0	No	Ramp XSlope (%)	3.5
N/A	Flare Type LT	N/A	N/A	Flare Type RT	N/A
N/A	Flare Slope LT (%)	N/A	N/A	Flare Slope RT (%)	N/A
N/A	Flare Traversable LT?	N/A	N/A	Flare Traversable RT?	N/A
N/A	Landing Length (in)	N/A	N/A	DWS Provided?	N/A
N/A	Landing Width (in)	N/A	N/A	DWS Contrast?	N/A
N/A	Landing Slope (%)	N/A	N/A	DWS Length (in)	N/A
N/A	Landing X Slope (%)	N/A	N/A	DWS Full Width?	N/A
N/A	Landing Curb? (Y/N)	N/A	N/A	DWS Offset (in)	N/A
N/A	Shared Landing?	N/A			
N/A	Gutter Ponding?	N/A	N/A	Gutter Slope (%)	N/A
N/A	Gutter Lip Ht (in)	N/A	N/A	Gutter X Slope (%)	N/A
N/A	Painted X Walk1?	No	N/A	Painted X Walk2?	No
	X Walk 1 Direction	To NE		X Walk 2 Direction	To NW
N/A	X Walk 1 Width (in)	N/A	N/A	X Walk 2 Width (in)	N/A
	X Walk 1 Slope (%)	1.8		X Walk 2 Slope (%)	2.9
	X Walk 1 X Slope (%)	4.7		X Walk 2 X Slope (%)	0.5

N/A	Ramp inside XWalk1?	N/A	N/A	Ramp inside XWalk2?	N/A
	Road Slope (%)	1.5	N/A	Clear Space?	N/A
	Road X Slope (%)	3.8	N/A	Clear Space to XWalk (in)	N/A
N/A	Any Obstructions?	N/A	N/A	Storm Grate/Utility Hazard?	N/A
	Obstruction Type			Storm Grate/Utility Type	
		N/A			N/A
		Yes		Surface Condition? (G/P)	Good

**Remove & Replace Curb Ramp With Two New Directional Ramps or Equivalent.**

Total Cost: \$ 3200.00
