Access Compliance Report

Public Rights-of-Way

(Curb Ramps)

Intersection ID: 48863	Main Street: STEELE_CREEK_RD	Cross Street: WALKER_BRANCH_DR	Location: SE
ADA ID: EB9A2FE9510D	Ramp Type: Perp	Initial Pass/Fail: Fail	Overall Compliance: No
Codes/Mitigation Info/Possible Solution			Severity Score: 10
			Field Measurements/Component Compliance

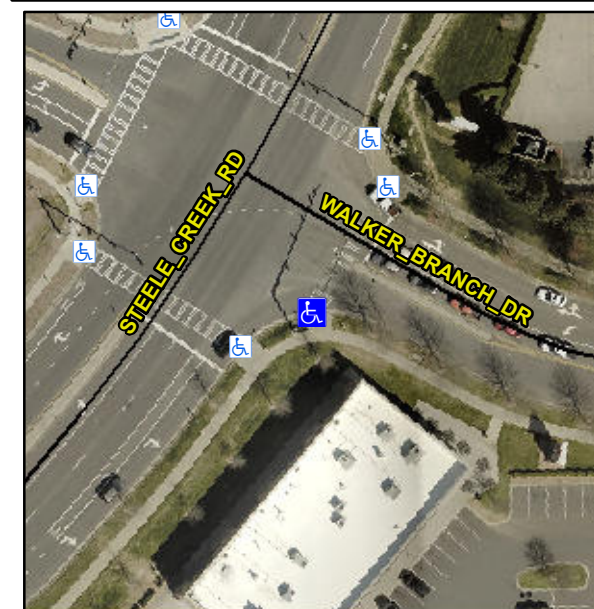
Not Found, R304.5.1, R304.5.3

Compliance	Description	Data	Compliance	Description	Data
N/A	Ramp Length (in)	96.0	Yes	Ramp Slope (%)	6.5
No	Ramp Width (in)	44.0	No	Ramp XSlope (%)	3.2
N/A	Flare Type LT	N/A	N/A	Flare Type RT	N/A
N/A	Flare Slope LT (%)	N/A	N/A	Flare Slope RT (%)	N/A
N/A	Flare Traversable LT?	N/A	N/A	Flare Traversable RT?	N/A
N/A	Landing Length (in)	N/A	N/A	DWS Provided?	N/A
N/A	Landing Width (in)	N/A	N/A	DWS Contrast?	N/A
N/A	Landing Slope (%)	N/A	N/A	DWS Length (in)	N/A
N/A	Landing X Slope (%)	N/A	N/A	DWS Full Width?	N/A
N/A	Landing Curb? (Y/N)	N/A	N/A	DWS Offset (in)	N/A
N/A	Shared Landing?	N/A			
N/A	Gutter Ponding?	N/A	N/A	Gutter Slope (%)	N/A
N/A	Gutter Lip Ht (in)	N/A	N/A	Gutter X Slope (%)	N/A
N/A	Painted X Walk1?	Yes	N/A	Painted X Walk2?	N/A
	X Walk 1 Direction	To NE		X Walk 2 Direction	N/A
N/A	X Walk 1 Width (in)	104.0	N/A	X Walk 2 Width (in)	N/A
	X Walk 1 Slope (%)	3.0		X Walk 2 Slope (%)	N/A
	X Walk 1 X Slope (%)	1.8		X Walk 2 X Slope (%)	N/A

N/A	Ramp inside XWalk1?	Yes	N/A	Ramp inside XWalk2?	N/A
	Road Slope (%)	N/A	N/A	Clear Space?	N/A
	Road X Slope (%)	N/A	N/A	Clear Space to XWalk (in)	N/A
N/A	Any Obstructions?	N/A	N/A	Storm Grate/Utility Hazard?	N/A
	Obstruction Type			Storm Grate/Utility Type	
		N/A			N/A
			Yes	Surface Condition? (G/P)	Good

Remove & Replace Entire Ramp.

Total Cost: \$ 1850.00
