## **Access Compliance Report Public Rights-of-Way** (Curb Ramps)

Intersection ID: N/A Main Street: S\_DAVIDSON\_ST **Cross Street: N/A** Location: **ADA ID: EBAFC1D4E208** Ramp Type: BlendTrans1 Initial Pass/Fail: Fail **Overall Compliance: No Severity Score:** 1.25

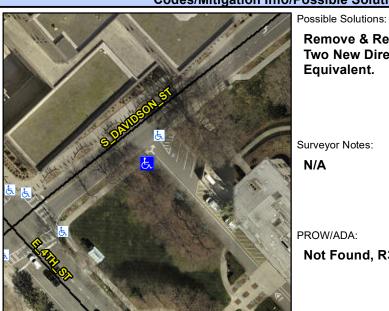
Not Found, R304.5.3

Field Measurements/Component Compliance					
Compliance Description		Data	Comp	liance Description	Data
N/A	Ramp Length (in)	38.0	Yes	BlendTrans Slope (%)	1.1
Yes	Ramp Width (in)	69.0	No	BlendTrans XSlope (%)	3.2
N/A	Flare Type LT	N/A	N/A	Flare Type RT	N/A
N/A	Flare Slope LT (%)	N/A	N/A	Flare Slope RT (%)	N/A
N/A	Flare Traversable LT?	No	N/A	Flare Traversable RT?	No
N/A	Landing Length (in)	N/A	N/A	DWS Provided?	N/A
N/A	Landing Width (in)	N/A	N/A	DWS Contrast?	N/A
N/A	Landing Slope (%)	N/A	N/A	DWS Length (in)	N/A
N/A	Landing X Slope (%)	N/A	N/A	DWS Full Width?	N/A
N/A	Landing Curb? (Y/N)	N/A	N/A	DWS Offset (in)	N/A
N/A	Shared Landing?	N/A			
N/A	Gutter Ponding?	N/A	N/A	Gutter Slope (%)	N/A
N/A	Gutter Lip Ht (in)	N/A	N/A	Gutter X Slope (%)	N/A
N/A	Painted X Walk1?	No	N/A	Painted X Walk2?	N/A
	X Walk 1 Direction	To NE		X Walk 2 Direction	N/A
	X Walk 1 Width (in)	N/A		X Walk 2 Width (in)	N/A
	X Walk 1 Slope (%)	2.8		X Walk 2 Slope (%)	N/A

X Walk 1 X Slope (%)	2.2		X Walk 2 X Slope (%)	N/A
N/A	Ramp inside XWalk1?	N/A	N/A	Ramp inside XWalk2?	N/A
	Road Slope (%)	2.2		Clear Space?	N/A
	Road X Slope (%)	2.8	N/A	Clear Space to XWalk (in)	N/A
N/A	Any Obstructions?	N/A	N/A	Storm Grate/Utility Hazard?	N/A
	Obstruction Type		l	Storm Grate/Utility Type	
		N/A	l		N/A
			Yes	Surface Condition? (G/P)	Good
			No	Curb Slope (%)	14.3

**S DAVIDSON ST** Street 1 Name Stop Condition-Street 1 StopSign Street 2 Name N/A Stop Condition-Street 2 N/A Remove & Replace Curb Ramp With Two New Directional Ramps or Equivalent.

3200.00
