Access Compliance Report

Public Rights-of-Way

(Curb Ramps)

| Intersection ID: 46497 | Main Street: NEWBRIDGE_RD | Cross Street: BALTRAY_RD | Location: SW |

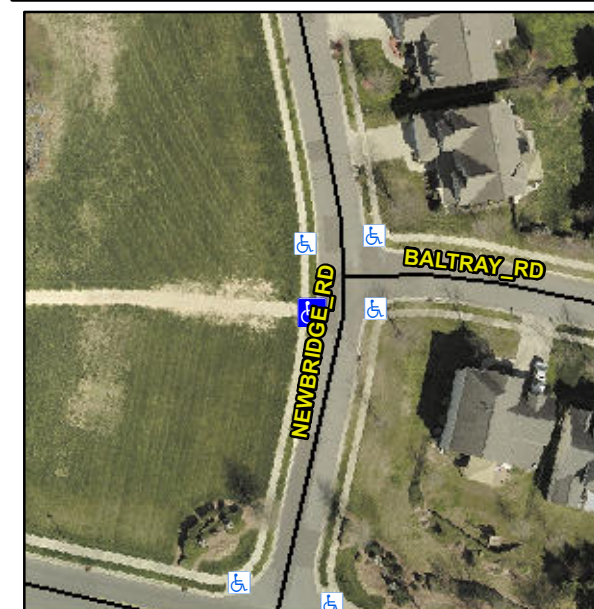
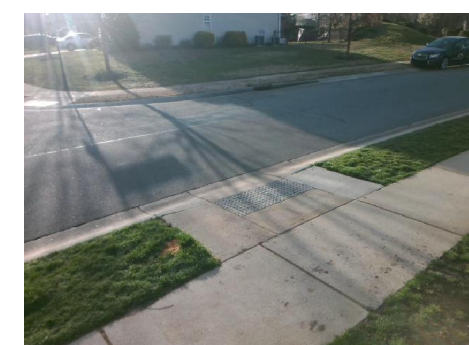
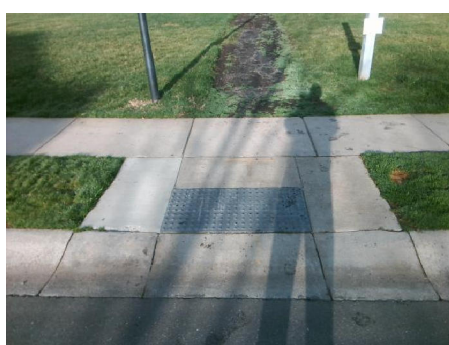
| ADA ID: EBC9BB55E7D1 | Ramp Type: Perp | Initial Pass/Fail: Fail | Overall Compliance: No |

Not Found, R304.2.2

| Compliance | Description | Data | Compliance | Description | Data |
|---|---|---|---|---|---|
| N/A | Ramp Length (in) | 48.0 | No | Ramp Slope (%) | 8.6 |

Remove & Replace Entire Ramp.
