Access Compliance Report

Public Rights-of-Way

(Curb Ramps)

Intersection ID: 3896	Main Street: DELLFIELD_WY	Cross Street: MALLARD_DR	Location: SE
ADA ID: EBD79488ED09	Ramp Type: Perp	Initial Pass/Fail: Fail	Overall Compliance: No
Severity Score: 22.5			
Codes/Mitigation Info/Possible Solution		Field Measurements/Component Compliance

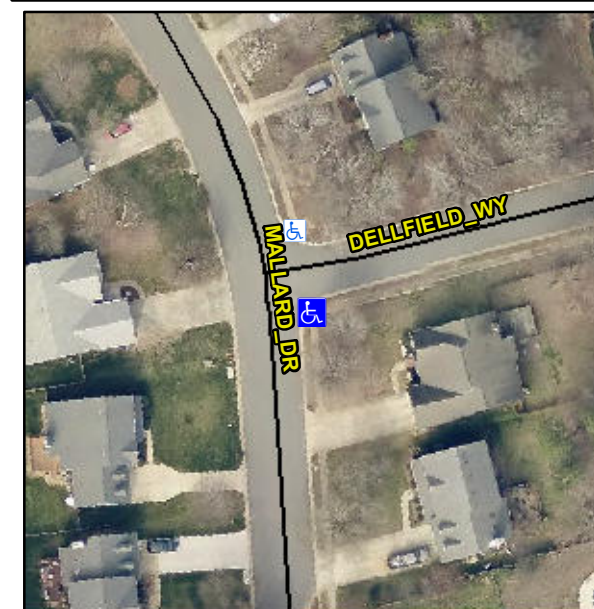
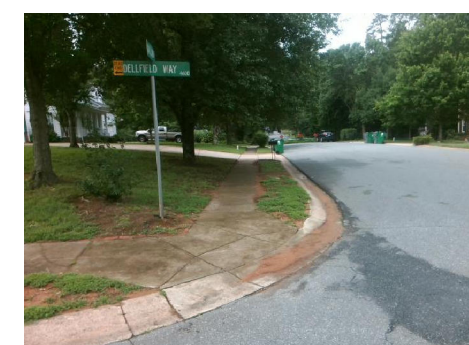
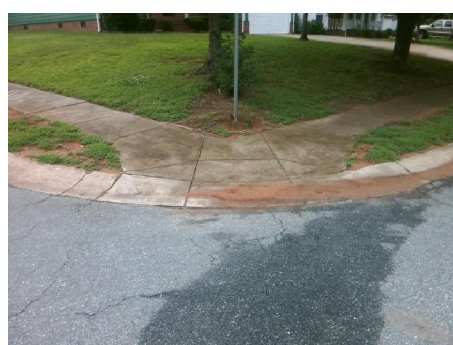
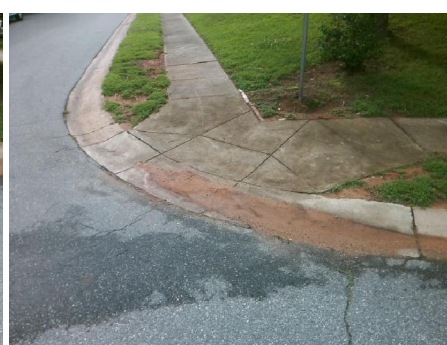
Not Found, R304.5.1, R304.2.2, R304.5.3

Compliance	Description	Data	Compliance	Description	Data
N/A	Ramp Length (in)	66.0	No	Ramp Slope (%)	10.3
No	Ramp Width (in)	38.5	No	Ramp XSlope (%)	3.6
N/A	Flare Type LT	N/A	N/A	Flare Type RT	N/A
N/A	Flare Slope LT (%)	N/A	N/A	Flare Slope RT (%)	N/A
N/A	Flare Traversable LT?	N/A	N/A	Flare Traversable RT?	N/A
N/A	Landing Length (in)	N/A	N/A	DWS Provided?	N/A
N/A	Landing Width (in)	N/A	N/A	DWS Contrast?	N/A
N/A	Landing Slope (%)	N/A	N/A	DWS Length (in)	N/A
N/A	Landing X Slope (%)	N/A	N/A	DWS Full Width?	N/A
N/A	Landing Curb? (Y/N)	N/A	N/A	DWS Offset (in)	N/A
N/A	Shared Landing?	N/A			
N/A	Gutter Ponding?	N/A	N/A	Gutter Slope (%)	N/A
N/A	Gutter Lip Ht (in)	N/A	N/A	Gutter X Slope (%)	N/A
N/A	Painted X Walk1?	No	N/A	Painted X Walk2?	N/A
	X Walk 1 Direction	To N		X Walk 2 Direction	N/A
N/A	X Walk 1 Width (in)	N/A	N/A	X Walk 2 Width (in)	N/A
	X Walk 1 Slope (%)	2.8		X Walk 2 Slope (%)	N/A
	X Walk 1 X Slope (%)	0.7		X Walk 2 X Slope (%)	N/A

N/A	Ramp inside XWalk1?	N/A	N/A	Ramp inside XWalk2?	N/A
	Road Slope (%)	N/A	N/A	Clear Space?	N/A
	Road X Slope (%)	N/A	N/A	Clear Space to XWalk (in)	N/A
N/A	Any Obstructions?	N/A	N/A	Storm Grate/Utility Hazard?	N/A
	Obstruction Type			Storm Grate/Utility Type	
		N/A			N/A
			Yes	Surface Condition? (G/P)	Good

Remove & Replace Entire Ramp.
