# Access Compliance Report

## Public Rights-of-Way

### (Curb Ramps)

| Intersection ID: 43650 | Main Street: CAMDEN_MEADOW_DR | Cross Street: BALLINDERRY_DR | Location: SE |

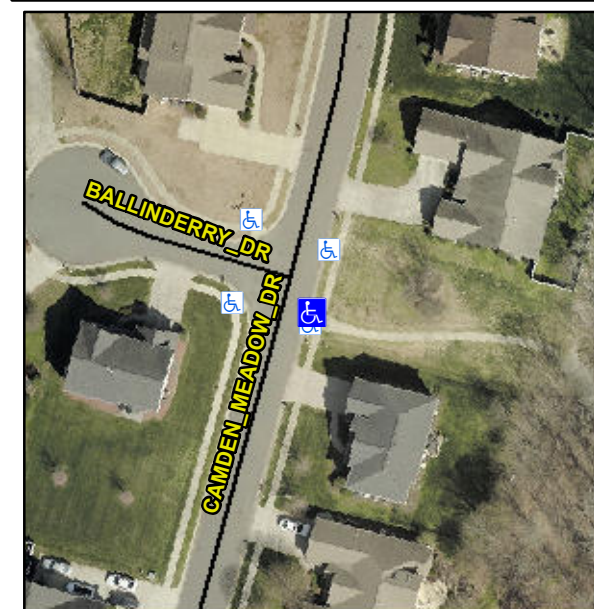
**Not Found, R304.2.2**

| Compliance | Description | Data | Compliance | Description | Data |
|---|---|---|---|---|---|
| N/A | Ramp Length (in) | 47.0 | No | Ramp Slope (%) | 12.3 |

**Remove & Replace Entire Ramp.**
