Access Compliance Report

Public Rights-of-Way

(Curb Ramps)

Intersection ID: 16266	Main Street: BEVERLY_DR	Cross Street: PORTLAND_AV	Location:	E
ADA ID: EBE516D8463E	Ramp Type: Perp	Initial Pass/Fail: Fail	Overall Compliance: No	Severity Score: 12.5
Codes/Mitigation Info/Possible Solution		Field Measurements/Component Compliance

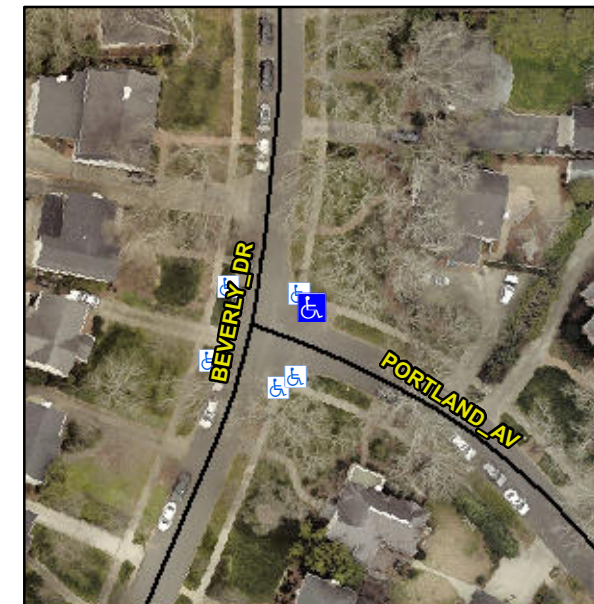
Not Found, R304.2.2

Compliance	Description	Data	Compliance	Description	Data
N/A	Ramp Length (in)	42.0	No	Ramp Slope (%)	8.8
Yes	Ramp Width (in)	114.0	Yes	Ramp XSlope (%)	0.4
N/A	Flare Type LT	N/A	N/A	Flare Type RT	N/A
N/A	Flare Slope LT (%)	N/A	N/A	Flare Slope RT (%)	N/A
N/A	Flare Traversable LT?	N/A	N/A	Flare Traversable RT?	N/A
N/A	Landing Length (in)	N/A	N/A	DWS Provided?	N/A
N/A	Landing Width (in)	N/A	N/A	DWS Contrast?	N/A
N/A	Landing Slope (%)	N/A	N/A	DWS Length (in)	N/A
N/A	Landing X Slope (%)	N/A	N/A	DWS Full Width?	N/A
N/A	Landing Curb? (Y/N)	N/A	N/A	DWS Offset (in)	N/A
N/A	Shared Landing?	N/A			
N/A	Gutter Ponding?	N/A	N/A	Gutter Slope (%)	N/A
N/A	Gutter Lip Ht (in)	N/A	N/A	Gutter X Slope (%)	N/A
N/A	Painted X Walk1?	No	N/A	Painted X Walk2?	N/A
	X Walk 1 Direction	To SW		X Walk 2 Direction	N/A
N/A	X Walk 1 Width (in)	N/A	N/A	X Walk 2 Width (in)	N/A
	X Walk 1 Slope (%)	3.2		X Walk 2 Slope (%)	N/A
	X Walk 1 X Slope (%)	3.1		X Walk 2 X Slope (%)	N/A

Remove & Replace Entire Ramp.

Total Cost: \$ 1850.00
