## Access Compliance Report Public Rights-of-Way (Curb Ramps)

Intersection ID: 29991 Main Street: BACKWATER\_DR Cross Street: NELAND\_LN Location: W

ADA ID: EBEE7356D3EC Ramp Type: Para Initial Pass/Fail: Fail Overall Compliance: No Severity Score: 13.75

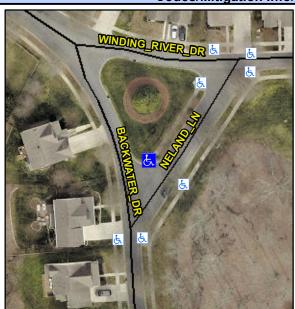
Fleid Measurements/Component Compliance							
Compliance Description		Data	Comp	liance Description	Data		
N/A	Ramp Length LT (in)	27.0	N/A	Ramp Length RT (in)	26.0		
Yes	Ramp Width LT (in)	48.0	Yes	Ramp Width RT (in)	48.0		
No	Ramp Slope LT (%)	9.7	No	Ramp Slope RT (%)	8.8		
Yes	Ramp XSlope LT (%)	0.8	No	Ramp XSlope RT (%)	2.3		
N/A	Landing Length (in)	N/A	N/A	DWS Provided?	N/A		
N/A	Landing Width (in)	N/A	N/A	DWS Contrast?	N/A		
N/A	Landing Slope (%)	N/A	N/A	DWS Length (in)	N/A		
N/A	Landing X Slope (%)	N/A	N/A	DWS Full Width?	N/A		
N/A	Landing Curb? (Y/N)	N/A	N/A	DWS Offset (in)	N/A		
N/A	Shared Landing?	N/A					
N/A	Gutter Ponding?	N/A	N/A	Gutter Slope (%)	N/A		
N/A	Gutter Lip Ht (in)	N/A	N/A	Gutter X Slope (%)	N/A		
N/A	Painted X Walk1?	No	N/A	Painted X Walk2?	N/A		
	X Walk 1 Direction	To E		X Walk 2 Direction	N/A		
N/A	X Walk 1 Width (in)	N/A	N/A	X Walk 2 Width (in)	N/A		
	X Walk 1 Slope (%)	4.0		X Walk 2 Slope (%)	N/A

X Walk 1 X Slope (%)	8.2		X Walk 2 X Slope (%)	N/A		
N/A	Ramp inside XWalk1?	N/A	N/A	Ramp inside XWalk2?	N/A		
	Road Slope (%)	N/A	N/A	Clear Space?	N/A		
	Road X Slope (%)	N/A	N/A	Clear Space to XWalk (in)	N/A		
N/A	Any Obstructions?	N/A	N/A	Storm Grate/Utility Hazard?	N/A		
	Obstruction Type			Storm Grate/Utility Type			
		N/A			N/A		
			Yes	Surface Condition? (G/P)	Good		
			N/A	Curb Slope (%)	18.5

Possible Solutions:	C
Remove & Replace Entire Ramp.	N/
	Ye
	No
	Ye
	N/
	N/
Surveyor Notes:	N/
N/A	N/
	N/
	N/
	N/
PROW/ADA:	N/
R304.3.2, R304.5.3	N/
	N/
	N/
