Access Compliance Report

Public Rights-of-Way

(Curb Ramps)

Intersection ID: 47845	Main Street: DEL_RIO_RD	Cross Street: CACTUS_VALLEY_RD	Location: NW
ADA ID: EBF3CE5EF27A	Ramp Type: PerpDiag	Initial Pass/Fail: Fail	Overall Compliance: No
			Severity Score: 21.25

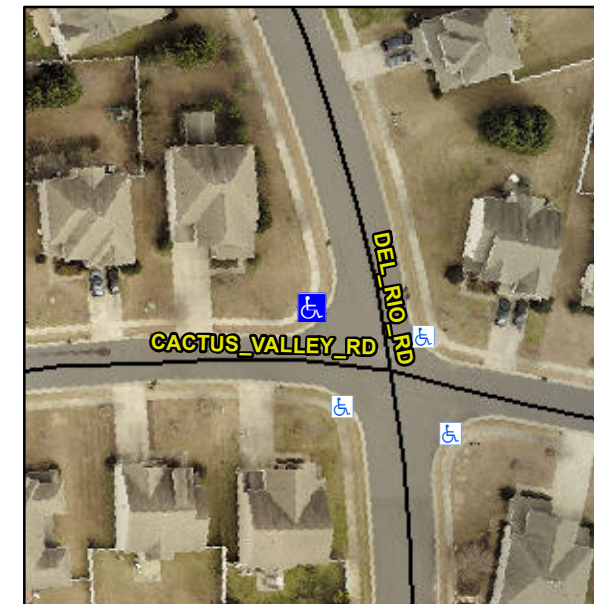
Not Found, R304.5.1, R304.5.3

Compliance	Description	Data	Compliance	Description	Data
N/A	Ramp Length (in)	60.0	Yes	Ramp Slope (%)	8.0
No	Ramp Width (in)	47.0	No	Ramp XSlope (%)	5.6
N/A	Flare Type LT	N/A	N/A	Flare Type RT	N/A
N/A	Flare Slope LT (%)	N/A	N/A	Flare Slope RT (%)	N/A
N/A	Flare Traversable LT?	N/A	N/A	Flare Traversable RT?	N/A
N/A	Landing Length (in)	N/A	N/A	DWS Provided?	N/A
N/A	Landing Width (in)	N/A	N/A	DWS Contrast?	N/A
N/A	Landing Slope (%)	N/A	N/A	DWS Length (in)	N/A
N/A	Landing X Slope (%)	N/A	N/A	DWS Full Width?	N/A
N/A	Landing Curb? (Y/N)	N/A	N/A	DWS Offset (in)	N/A
N/A	Shared Landing?	N/A			
N/A	Gutter Ponding?	N/A	N/A	Gutter Slope (%)	N/A
N/A	Gutter Lip Ht (in)	N/A	N/A	Gutter X Slope (%)	N/A
N/A	Painted X Walk1?	No	N/A	Painted X Walk2?	No
	X Walk 1 Direction	To S		X Walk 2 Direction	To SE
N/A	X Walk 1 Width (in)	N/A	N/A	X Walk 2 Width (in)	N/A
	X Walk 1 Slope (%)	1.8		X Walk 2 Slope (%)	2.4
	X Walk 1 X Slope (%)	3.9		X Walk 2 X Slope (%)	3.1

N/A	Ramp inside XWalk1?	N/A	N/A	Ramp inside XWalk2?	N/A
	Road Slope (%)	3.6	N/A	Clear Space?	N/A
	Road X Slope (%)	0.0	N/A	Clear Space to XWalk (in)	N/A
N/A	Any Obstructions?	N/A	N/A	Storm Grate/Utility Hazard?	N/A
	Obstruction Type			Storm Grate/Utility Type	
		N/A			N/A
			Yes	Surface Condition? (G/P)	Good

Possible Solutions:

Remove & Replace Curb Ramp With Two New Directional Ramps or Equivalent.
