# Access Compliance Report

## Public Rights-of-Way

### (Curb Ramps)

Intersection ID: 48410	Main Street: CAIRNS_MILL_CT	Cross Street: BELMAR_PLACE_RD	Location: SE
ADA ID: EBF63EB95D2D	Ramp Type: Perp	Initial Pass/Fail: Fail	Overall Compliance: No
Codes/Mitigation Info/Possible Solution		Field Measurements/Component Compliance	
Severity Score: 13.75

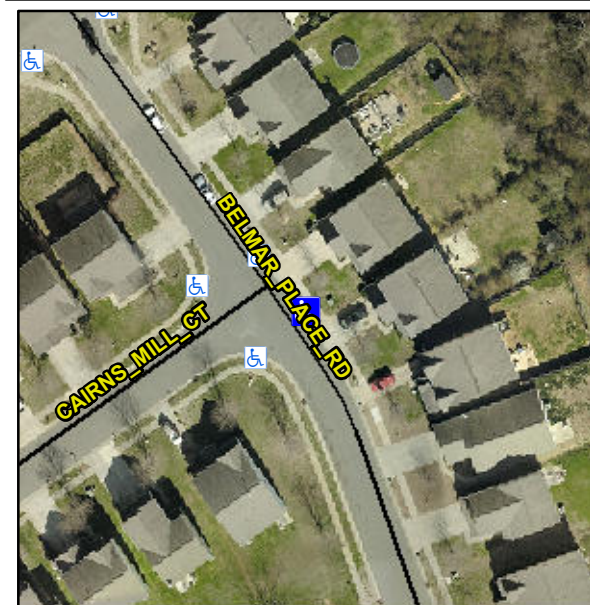
**Not Found, R304.2.2**

Compliance	Description	Data	Compliance	Description	Data
N/A	Ramp Length (in)	48.0	No	Ramp Slope (%)	8.4
Yes	Ramp Width (in)	48.0	Yes	Ramp XSlope (%)	3.0
N/A	Flare Type LT	N/A	N/A	Flare Type RT	N/A
N/A	Flare Slope LT (%)	N/A	N/A	Flare Slope RT (%)	N/A
N/A	Flare Traversable LT?	N/A	N/A	Flare Traversable RT?	N/A
N/A	Landing Length (in)	N/A	N/A	DWS Provided?	N/A
N/A	Landing Width (in)	N/A	N/A	DWS Contrast?	N/A
N/A	Landing Slope (%)	N/A	N/A	DWS Length (in)	N/A
N/A	Landing X Slope (%)	N/A	N/A	DWS Full Width?	N/A
N/A	Landing Curb? (Y/N)	N/A	N/A	DWS Offset (in)	N/A
N/A	Shared Landing?	N/A			
N/A	Gutter Ponding?	N/A	N/A	Gutter Slope (%)	N/A
N/A	Gutter Lip Ht (in)	N/A	N/A	Gutter X Slope (%)	N/A
N/A	Painted X Walk1?	No	N/A	Painted X Walk2?	N/A
	X Walk 1 Direction	To W		X Walk 2 Direction	N/A
N/A	X Walk 1 Width (in)	N/A	N/A	X Walk 2 Width (in)	N/A
	X Walk 1 Slope (%)	0.9		X Walk 2 Slope (%)	N/A
	X Walk 1 X Slope (%)	3.0		X Walk 2 X Slope (%)	N/A

N/A	Ramp inside XWalk1?	N/A	N/A	Ramp inside XWalk2?	N/A
	Road Slope (%)	N/A	N/A	Clear Space?	N/A
	Road X Slope (%)	N/A	N/A	Clear Space to XWalk (in)	N/A
N/A	Any Obstructions?	N/A	N/A	Storm Grate/Utility Hazard?	N/A
	Obstruction Type			Storm Grate/Utility Type	
		N/A			N/A
			Yes	Surface Condition? (G/P)	Good

**Remove & Replace Entire Ramp.**
