Access Compliance Report

Public Rights-of-Way

(Curb Ramps)

Intersection ID: 9661	Main Street: CAMROSE_DR	Cross Street: THE_PLAZA	Location: SW
ADA ID: EBFEB1D08F90	Ramp Type: Perp	Initial Pass/Fail: Fail	Overall Compliance: No
		Severity Score: 12.5

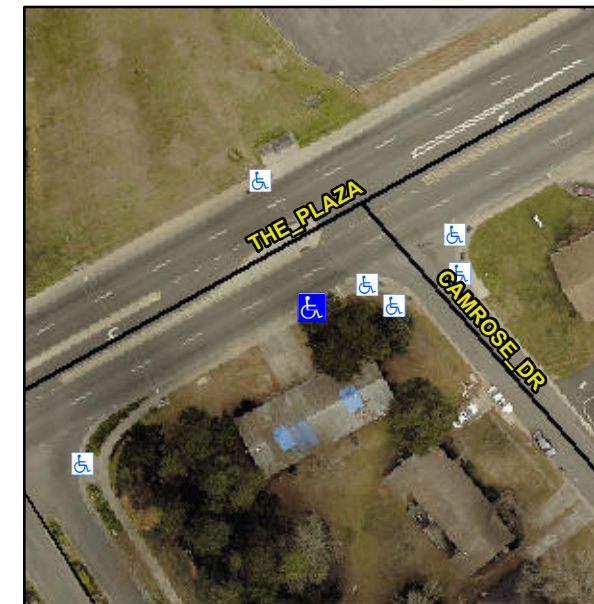
Not Found, R304.2.2

Compliance	Description	Data	Compliance	Description	Data
N/A	Ramp Length (in)	66.0	No	Ramp Slope (%)	8.9
Yes	Ramp Width (in)	48.0	Yes	Ramp XSlope (%)	1.3
N/A	Flare Type LT	N/A	N/A	Flare Type RT	N/A
N/A	Flare Slope LT (%)	N/A	N/A	Flare Slope RT (%)	N/A
N/A	Flare Traversable LT?	N/A	N/A	Flare Traversable RT?	N/A
N/A	Landing Length (in)	N/A	N/A	DWS Provided?	N/A
N/A	Landing Width (in)	N/A	N/A	DWS Contrast?	N/A
N/A	Landing Slope (%)	N/A	N/A	DWS Length (in)	N/A
N/A	Landing X Slope (%)	N/A	N/A	DWS Full Width?	N/A
N/A	Landing Curb? (Y/N)	N/A	N/A	DWS Offset (in)	N/A
N/A	Shared Landing?	N/A			
N/A	Gutter Ponding?	N/A	N/A	Gutter Slope (%)	N/A
N/A	Gutter Lip Ht (in)	N/A	N/A	Gutter X Slope (%)	N/A
N/A	Painted X Walk1?	No	N/A	Painted X Walk2?	N/A
	X Walk 1 Direction	To NW		X Walk 2 Direction	N/A
N/A	X Walk 1 Width (in)	N/A	N/A	X Walk 2 Width (in)	N/A
	X Walk 1 Slope (%)	2.8		X Walk 2 Slope (%)	N/A
	X Walk 1 X Slope (%)	0.8		X Walk 2 X Slope (%)	N/A

Remove & Replace Entire Ramp.
