Access Compliance Report Public Rights-of-Way (Curb Ramps)

| Intersection ID: 44730 | Main Street: BENFIELD_RD | Cross Street: KOTLIK_DR | Location: E |
| ADA ID: EC1C72969244 | Ramp Type: Directional1 | Initial Pass/Fail: Fail | Overall Compliance: No Severity Score: 37.5 |

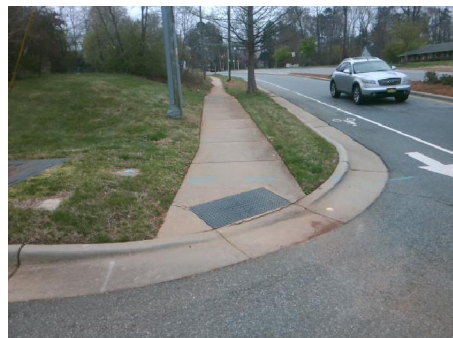
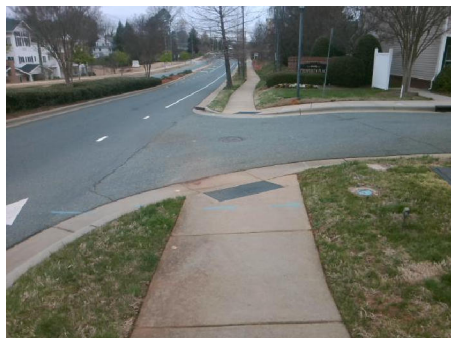
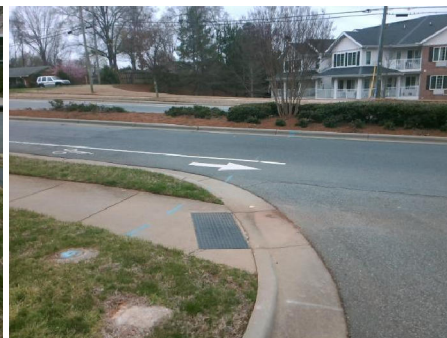
R304.2.2, R304.5.3

| Compliance | Description | Data | Compliance | Description | Data |
|---|---|---|---|---|---|
| No | Ramp Slope (%) | 12.0 | N/A | Grade Break XSlope (%) | 0.0 |
| No | Ramp XSlope (%) | 6.6 | | | |

Remove & Replace Entire Ramp.
