Access Compliance Report

Public Rights-of-Way (Curb Ramps)

Intersection ID: 18738	Main Street: FERNCLIFF_RD	Cross Street: SHARON_RD	Location: NE
ADA ID: EC1F81C24B07	Ramp Type: PerpDiag	Initial Pass/Fail: Fail	Overall Compliance: No
			Severity Score: 21.25

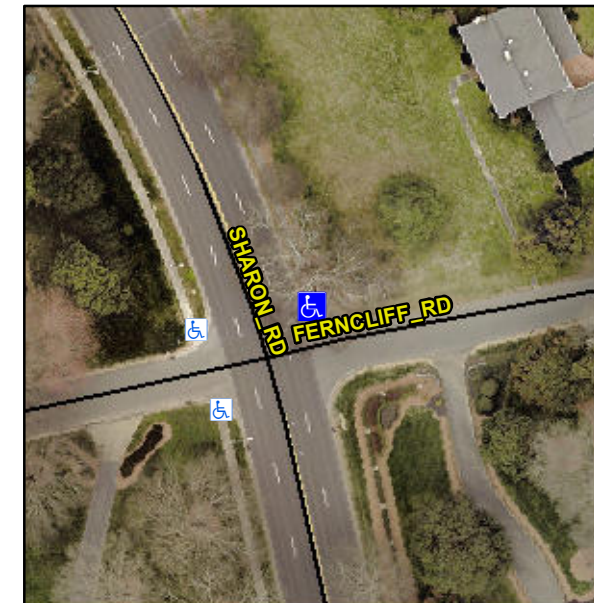
Not Found, R304.5.1, R304.2.2

Compliance	Description	Data	Compliance	Description	Data
N/A	Ramp Length (in)	83.0	No	Ramp Slope (%)	11.2
No	Ramp Width (in)	38.0	Yes	Ramp XSlope (%)	0.2
N/A	Flare Type LT	N/A	N/A	Flare Type RT	N/A
N/A	Flare Slope LT (%)	N/A	N/A	Flare Slope RT (%)	N/A
N/A	Flare Traversable LT?	N/A	N/A	Flare Traversable RT?	N/A
N/A	Landing Length (in)	N/A	N/A	DWS Provided?	N/A
N/A	Landing Width (in)	N/A	N/A	DWS Contrast?	N/A
N/A	Landing Slope (%)	N/A	N/A	DWS Length (in)	N/A
N/A	Landing X Slope (%)	N/A	N/A	DWS Full Width?	N/A
N/A	Landing Curb? (Y/N)	N/A	N/A	DWS Offset (in)	N/A
N/A	Shared Landing?	N/A			
N/A	Gutter Ponding?	N/A	N/A	Gutter Slope (%)	N/A
N/A	Gutter Lip Ht (in)	N/A	N/A	Gutter X Slope (%)	N/A
N/A	Painted X Walk1?	No	N/A	Painted X Walk2?	No
	X Walk 1 Direction	To W		X Walk 2 Direction	To S
N/A	X Walk 1 Width (in)	N/A	N/A	X Walk 2 Width (in)	N/A
	X Walk 1 Slope (%)	4.1		X Walk 2 Slope (%)	1.2
	X Walk 1 X Slope (%)	0.0		X Walk 2 X Slope (%)	7.3

N/A	Ramp inside XWalk1?	N/A	N/A	Ramp inside XWalk2?	N/A
	Road Slope (%)	3.6	N/A	Clear Space?	N/A
	Road X Slope (%)	0.8	N/A	Clear Space to XWalk (in)	N/A
N/A	Any Obstructions?	N/A	N/A	Storm Grate/Utility Hazard?	N/A
	Obstruction Type			Storm Grate/Utility Type	
		N/A			N/A
			Yes	Surface Condition? (G/P)	Good

Remove & Replace Curb Ramp With Two New Directional Ramps or Equivalent.

Total Cost: \$ 3200.00
