# Access Compliance Report

## Public Rights-of-Way

Intersection ID: 14182	Main Street: E_PARK_AV	Cross Street: LYNDHURST_AV	Location: S
ADA ID: EC1F89EC31B4	Ramp Type: Perp	Initial Pass/Fail: Fail	Overall Compliance: No
Severity Score: 21.25			
Codes/Mitigation Info/Possible Solution		Field Measurements/Component Compliance

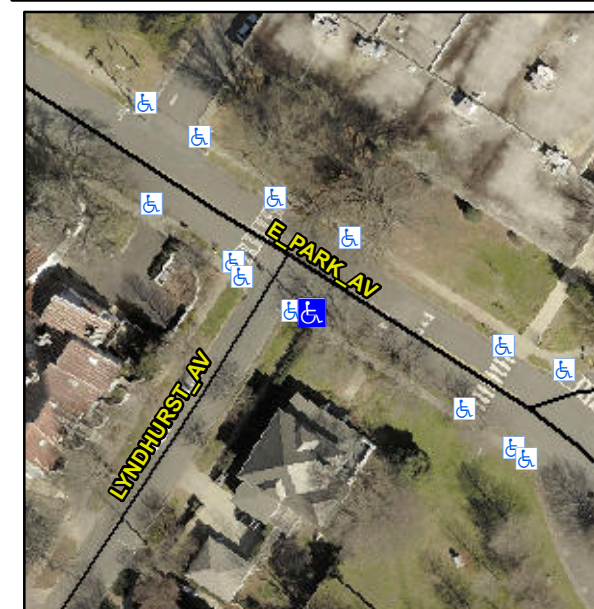
**N/A**

**R304.5.1, R304.2.2**

Compliance	Description	Data	Compliance	Description	Data
N/A	Ramp Length (in)	47.0	No	Ramp Slope (%)	11.5
No	Ramp Width (in)	36.0	Yes	Ramp XSlope (%)	0.9
N/A	Flare Type LT	N/A	N/A	Flare Type RT	N/A
N/A	Flare Slope LT (%)	N/A	N/A	Flare Slope RT (%)	N/A
N/A	Flare Traversable LT?	N/A	N/A	Flare Traversable RT?	N/A
N/A	Landing Length (in)	N/A	N/A	DWS Provided?	N/A
N/A	Landing Width (in)	N/A	N/A	DWS Contrast?	N/A
N/A	Landing Slope (%)	N/A	N/A	DWS Length (in)	N/A
N/A	Landing X Slope (%)	N/A	N/A	DWS Full Width?	N/A
N/A	Landing Curb? (Y/N)	N/A	N/A	DWS Offset (in)	N/A
N/A	Shared Landing?	N/A			
N/A	Gutter Ponding?	N/A	N/A	Gutter Slope (%)	N/A
N/A	Gutter Lip Ht (in)	3.0	N/A	Gutter X Slope (%)	N/A
N/A	Painted X Walk1?	No	N/A	Painted X Walk2?	N/A
	X Walk 1 Direction	To NE		X Walk 2 Direction	N/A
N/A	X Walk 1 Width (in)	N/A	N/A	X Walk 2 Width (in)	N/A
	X Walk 1 Slope (%)	6.5		X Walk 2 Slope (%)	N/A
	X Walk 1 X Slope (%)	5.4		X Walk 2 X Slope (%)	N/A

N/A	Ramp inside XWalk1?	N/A	N/A	Ramp inside XWalk2?	N/A
	Road Slope (%)	N/A	N/A	Clear Space?	N/A
	Road X Slope (%)	N/A	N/A	Clear Space to XWalk (in)	N/A
N/A	Any Obstructions?	N/A	N/A	Storm Grate/Utility Hazard?	N/A
	Obstruction Type			Storm Grate/Utility Type	
		N/A			N/A
			Yes	Surface Condition? (G/P)	Good

**Remove & Replace Entire Ramp.**

Total Cost: \$ 1850.00
