Access Compliance Report Public Rights-of-Way (Curb Ramps)

Intersection ID: 14397 Main Street: BROOKHILL_RD Cross Street: REMOUNT_RD Location: E

ADA ID: EC2901656148 Ramp Type: PerpDiag Initial Pass/Fail: Fail Overall Compliance: No Severity Score: 12.5

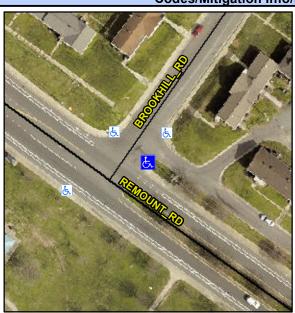
Not Found, R304.2.2

Comp	oliance Description	Data	Comp	liance	Description	Data
N/A	Ramp Length (in)	60.0	No	Ramp	Slope (%)	9.6
Yes	Ramp Width (in)	48.0	Yes	Ramp	XSlope (%)	0.1
N/A	Flare Type LT	N/A	N/A	Flare	Type RT	N/A
N/A	Flare Slope LT (%)	N/A	N/A	Flare	Slope RT (%)	N/A
N/A	Flare Traversable LT?	N/A	N/A	Flare	Traversable RT?	N/A
N/A	Landing Length (in)	N/A	N/A	DWS	Provided?	N/A
N/A	Landing Width (in)	N/A	N/A	DWS	Contrast?	N/A
N/A	Landing Slope (%)	N/A	N/A	DWS	Length (in)	N/A
N/A	Landing X Slope (%)	N/A	N/A	DWS	Full Width?	N/A
N/A	Landing Curb? (Y/N)	N/A	N/A	DWS	Offset (in)	N/A
N/A	Shared Landing?	N/A				
N/A	Gutter Ponding?	N/A	N/A	Gutte	r Slope (%)	N/A
N/A	Gutter Lip Ht (in)	N/A	N/A	Gutte	r X Slope (%)	N/A
N/A	Painted X Walk1?	No	N/A	Paint	ed X Walk2?	No
	X Walk 1 Direction	To NW		X Wa	lk 2 Direction	To SW
N/A	X Walk 1 Width (in)	N/A	N/A	X Wa	lk 2 Width (in)	N/A
	X Walk 1 Slope (%)	3.1		X Wa	lk 2 Slope (%)	2.9
	X Walk 1 X Slope (%)	0.5		X Wa	lk 2 X Slope (%)	1.5

N/A	Ramp inside XWalk1?	N/A	N/A	Ramp	inside XWalk2?	N/A
	Road Slope (%)	1.1	N/A	Clear	Space?	N/A
	Road X Slope (%)	3.8	N/A	Clear	Space to XWalk (in)	N/A
N/A	Any Obstructions?	N/A	N/A	Storm	Grate/Utility Hazard?	N/A
	Obstruction Type		l	Storm	Grate/Utility Type	
		N/A				N/A

Remove & Replace Curb Ramp With
Two New Directional Ramps or
Equivalent.
