# Access Compliance Report

## Public Rights-of-Way (Curb Ramps)

Intersection ID: 53762	Main Street: W_W_T_HARRIS_BV	Cross Street: SINGH_DR	Location: SW
ADA ID: EC2FFA2F91B2	Ramp Type: Directional1	Initial Pass/Fail: Pass	Overall Compliance: No
		Severity Score: 0

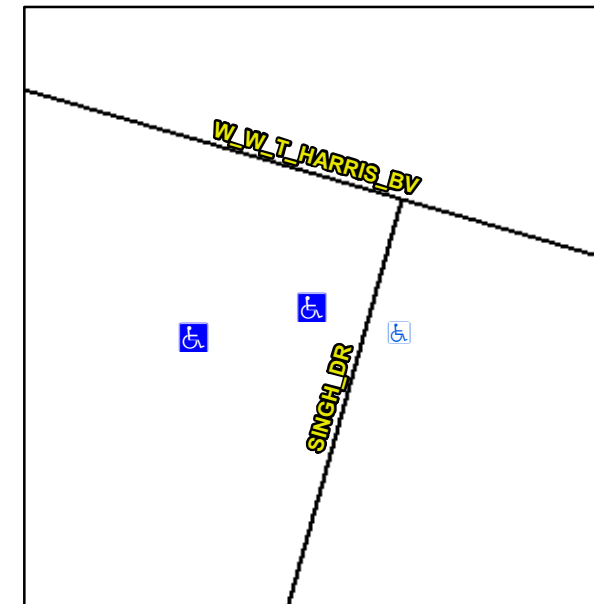
Compliance	Description	Data	Compliance	Description	Data
N/A	Ramp Length (in)	62.0	N/A	Grade Break?	N/A
Yes	Ramp Width (in)	59.0	N/A	Grade Break Slope (%)	0.0
Yes	Ramp Slope (%)	4.5	N/A	Grade Break XSlope (%)	0.0
Yes	Ramp XSlope (%)	2.0			
Yes	Flare Type LT	N/A	Yes	Flare Type RT	N/A
N/A	Flare Slope LT (%)	N/A	N/A	Flare Slope RT (%)	N/A
N/A	Flare Traversable LT?	No	N/A	Flare Traversable RT?	No
Yes	Landing Length (in)	95.0	Yes	DWS Provided?	Yes
Yes	Landing Width (in)	63.0	Yes	DWS Contrast?	Yes
Yes	Landing Slope (%)	1.6	Yes	DWS Length (in)	24.0
Yes	Landing X Slope (%)	2.0	Yes	DWS Full Width?	Yes
N/A	Landing Curb? (Y/N)	No	Yes	DWS Offset LT (in)	34.0
N/A	Shared Landing?	No	Yes	DWS Offset RT (in)	0.0
Yes	Gutter Ponding?	No	Yes	Gutter Slope (%)	1.3
Yes	Gutter Lip Ht (in)	0.0	No	Gutter X Slope (%)	5.1
N/A	Painted X Walk1?	No		Road Slope (%)	1.8
	X Walk 1 Direction	To E		Road X Slope (%)	5.5
	X Walk 1 Width (in)	N/A		Clear Space?	Yes

X Walk 1 Slope (%)	1.8	N/A	Clear Space to XWalk (in)	N/A
	X Walk 1 X Slope (%)	5.5	Yes	Storm Grate/Utility Hazard?	No
N/A	Ramp inside XWalk1?	N/A		Storm Grate/Utility Type	
Yes	Any Obstructions?	No			N/A
	Obstruction Type		Yes	Surface Condition? (G/P)	Good
			N/A	Curb Slope (%)	N/A

**Remove & Replace Gutter.**

**R304.5.3**

\$ 750.00

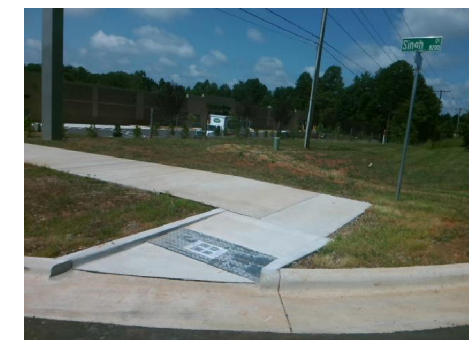
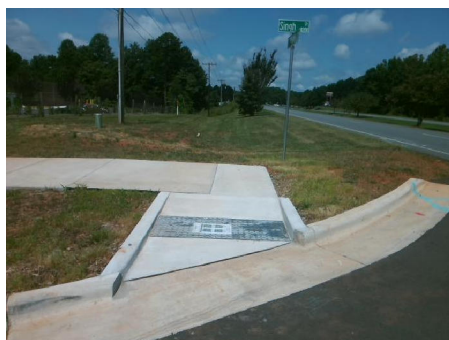
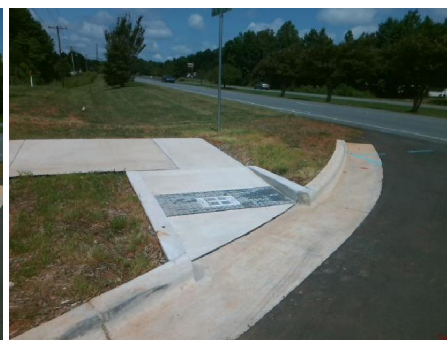
**NO RT SW**
