Intersection ID: 10023016	Main Street: CENTER_PARK_DR	Cross Street: N/A	Location:	NE
ADA ID: EC3067A745BB	Ramp Type: PerpDiag	Initial Pass/Fail: Fail	Overall Compliance: No	Severity Score: 13.75

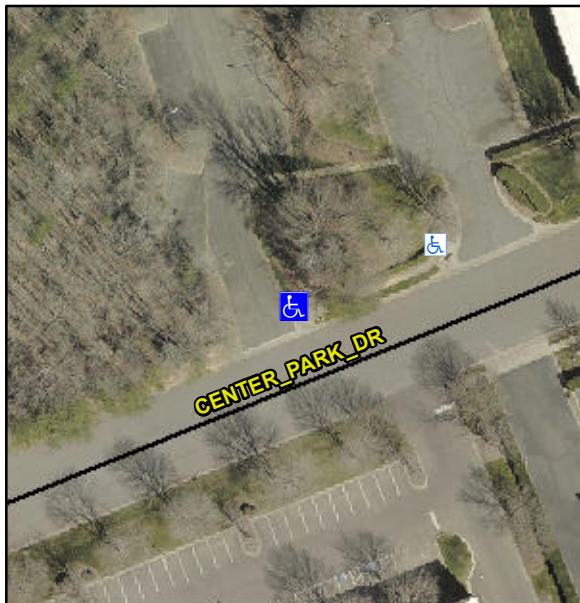
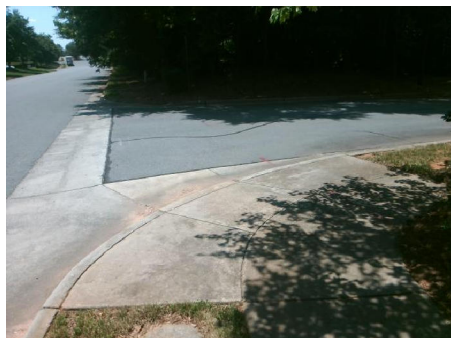
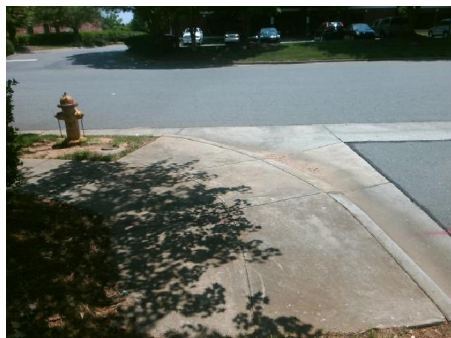
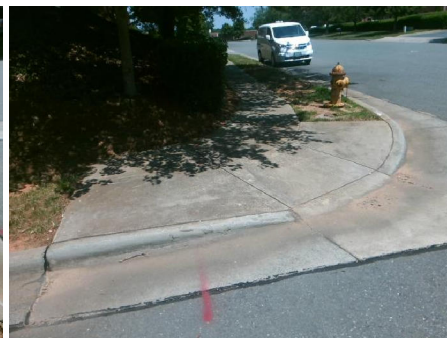
Possible Solutions:		Remove & Replace Curb Ramp With Two New Directional Ramps or Equivalent.			Compliance	Description	Data	Compliance	Description	Data
						N/A	Ramp Length (in)	47.0	No	Ramp Slope (%)	9.2
						Yes	Ramp Width (in)	51.0	No	Ramp XSlope (%)	2.3
						N/A	Flare Type LT	N/A	N/A	Flare Type RT	N/A
						N/A	Flare Slope LT (%)	N/A	N/A	Flare Slope RT (%)	N/A
						N/A	Flare Traversable LT?	N/A	N/A	Flare Traversable RT?	N/A
						N/A	Landing Length (in)	N/A	N/A	DWS Provided?	N/A
						N/A	Landing Width (in)	N/A	N/A	DWS Contrast?	N/A
						N/A	Landing Slope (%)	N/A	N/A	DWS Length (in)	N/A
						N/A	Landing X Slope (%)	N/A	N/A	DWS Full Width?	N/A
Surveyor Notes:		N/A			N/A	Landing Curb? (Y/N)	N/A	N/A	DWS Offset (in)	N/A	
PROW/ADA:		R304.2.2, R304.5.3			N/A	Shared Landing?	N/A	N/A	Gutter Slope (%)	N/A	
					N/A	Gutter Ponding?	N/A	N/A	Gutter X Slope (%)	N/A

N/A	Gutter Lip Ht (in)	N/A	N/A	Painted X Walk2?	No	
						Painted X Walk1?	No	N/A	X Walk 2 Direction	To W	
						X Walk 1 Direction	To W	N/A	X Walk 2 Width (in)	N/A	
					N/A	X Walk 1 Width (in)	N/A	N/A	X Walk 2 Slope (%)	3.5	
						X Walk 1 Slope (%)	1.8		X Walk 2 X Slope (%)	0.1	
						X Walk 1 X Slope (%)	2.9		Ramp inside XWalk2?	N/A	
Street 1 Name		ENTRANCE			N/A	Ramp inside XWalk1?	N/A	N/A	Clear Space?	N/A	
Stop Condition-Street 2		StopSign				Road Slope (%)	0.6	N/A	Clear Space to XWalk (in)	N/A	
Street 2 Name		CENTER PARK DR				Road X Slope (%)	5.1	N/A	Storm Grate/Utility Hazard?	N/A	
Stop Condition-Street 1		None				Any Obstructions?	N/A	N/A	Storm Grate/Utility Type		
						Obstruction Type		N/A		N/A	
Total Cost:		\$ 3200.00							Yes	Surface Condition? (G/P)	Good
