Access Compliance Report

Public Rights-of-Way

(Curb Ramps)

Intersection ID: 30419	Main Street: ELM_BEND_DR	Cross Street: FENWAY_DR	Location: SE
ADA ID: EC34AD27F5FE	Ramp Type: PerpDiag	Initial Pass/Fail: Fail	Overall Compliance: No
Severity Score: 13.75			
Codes/Mitigation Info/Possible Solution		Field Measurements/Component Compliance

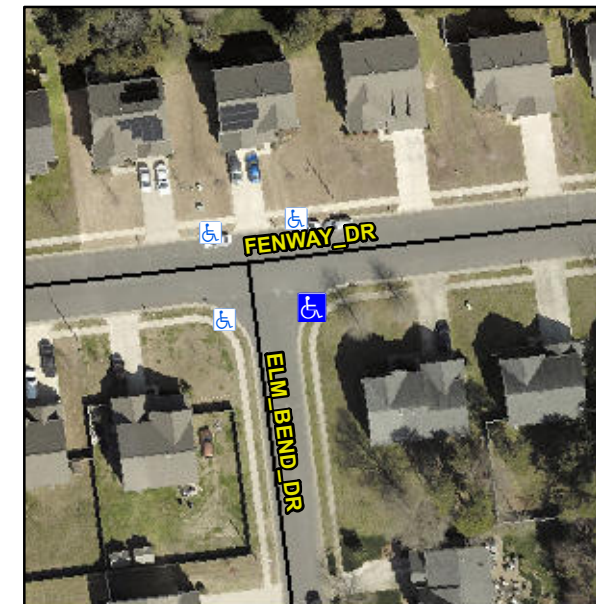
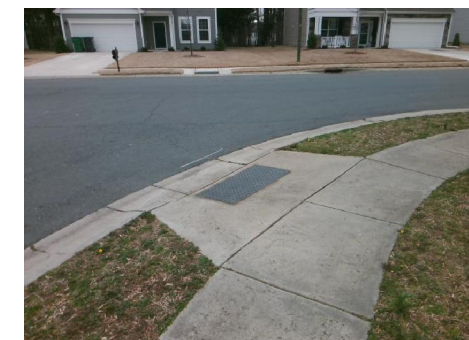
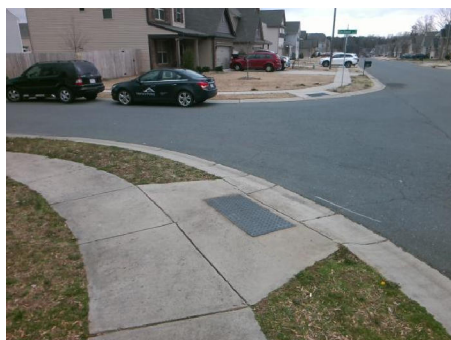
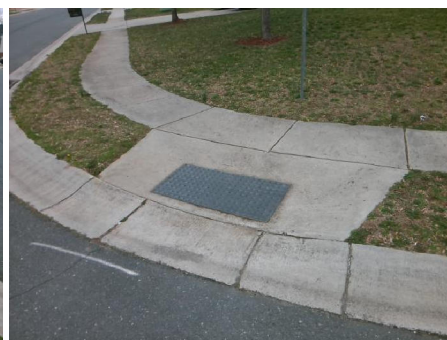
Compliance	Description	Data	Compliance	Description	Data
N/A	Ramp Length (in)	52.0	No	Ramp Slope (%)	9.2
Yes	Ramp Width (in)	48.0	No	Ramp XSlope (%)	3.3
N/A	Flare Type LT	N/A	N/A	Flare Type RT	N/A
N/A	Flare Slope LT (%)	N/A	N/A	Flare Slope RT (%)	N/A
N/A	Flare Traversable LT?	N/A	N/A	Flare Traversable RT?	N/A
N/A	Landing Length (in)	N/A	N/A	DWS Provided?	N/A
N/A	Landing Width (in)	N/A	N/A	DWS Contrast?	N/A
N/A	Landing Slope (%)	N/A	N/A	DWS Length (in)	N/A
N/A	Landing X Slope (%)	N/A	N/A	DWS Full Width?	N/A
N/A	Landing Curb? (Y/N)	N/A	N/A	DWS Offset (in)	N/A
N/A	Shared Landing?	N/A			
N/A	Gutter Ponding?	N/A	N/A	Gutter Slope (%)	N/A
N/A	Gutter Lip Ht (in)	N/A	N/A	Gutter X Slope (%)	N/A
N/A	Painted X Walk1?	No	N/A	Painted X Walk2?	No
	X Walk 1 Direction	To N		X Walk 2 Direction	To W
N/A	X Walk 1 Width (in)	N/A	N/A	X Walk 2 Width (in)	N/A
	X Walk 1 Slope (%)	1.8		X Walk 2 Slope (%)	2.5
	X Walk 1 X Slope (%)	1.1		X Walk 2 X Slope (%)	2.4

N/A	Ramp inside XWalk1?	N/A	N/A	Ramp inside XWalk2?	N/A
	Road Slope (%)	2.2	N/A	Clear Space?	N/A
	Road X Slope (%)	2.0	N/A	Clear Space to XWalk (in)	N/A
N/A	Any Obstructions?	N/A	N/A	Storm Grate/Utility Hazard?	N/A
	Obstruction Type			Storm Grate/Utility Type	
		N/A			N/A
		Yes		Surface Condition? (G/P)	Good

Remove & Replace Curb Ramp With Two New Directional Ramps or Equivalent.

R304.2.2, R304.5.3
