Access Compliance Report

Public Rights-of-Way

(Curb Ramps)

| Intersection ID: 43681 | Main Street: WALKER_RD | Cross Street: TODDINGTON_LN | Location: SW |

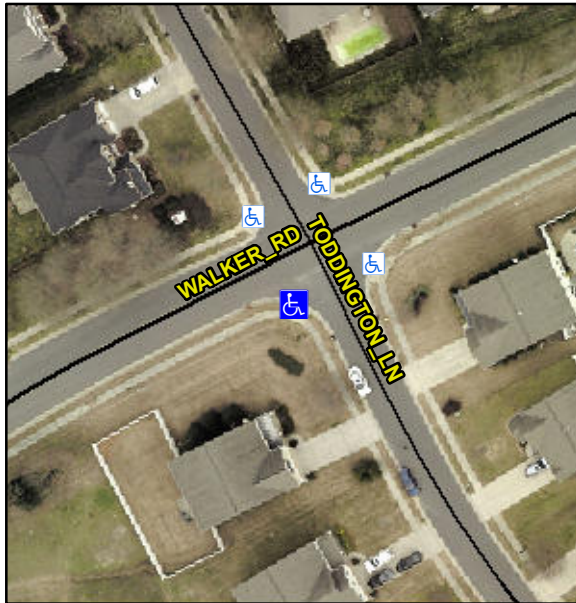
| ADA ID: EC3FBF5D2AB1 | Ramp Type: PerpDiag | Initial Pass/Fail: Fail | Overall Compliance: No |
| Severity Score: 8.75 | | | |

Not Found, R304.5.1

| Compliance | Description | Data | Compliance | Description | Data |
|---|---|---|---|---|---|
| No | Ramp Width (in) | 47.5 | Yes | Ramp XSlope (%) | 1.3 |

Remove & Replace Curb Ramp With Two New Directional Ramps or Equivalent.
