# Access Compliance Report

## Public Rights-of-Way

### (Curb Ramps)

| Intersection ID: 31876 | Main Street: ARABELLA_DR | Cross Street: WILLIAMS_GLENN_RD | Location: NW |

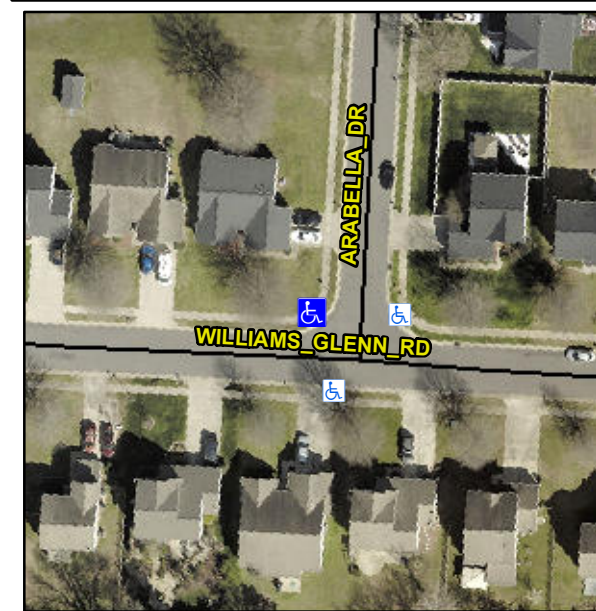
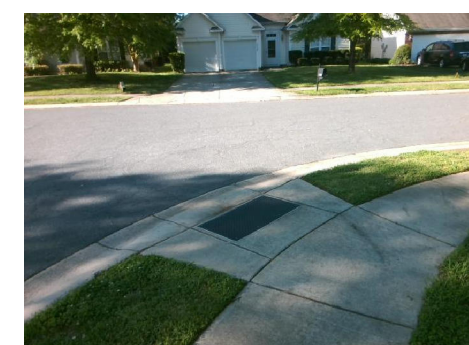
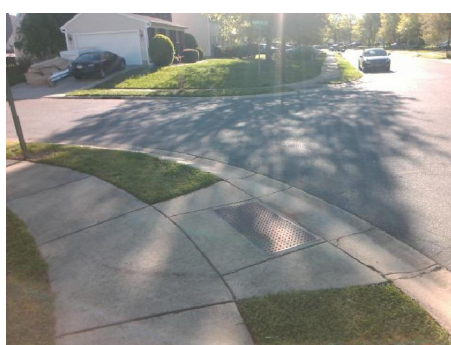
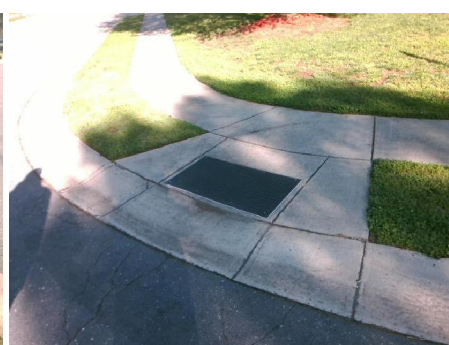
| ADA ID: EC4D8B99A1EA | Ramp Type: PerpDiag | Initial Pass/Fail: Fail | Overall Compliance: No |

| Compliance | Description | Data | Compliance | Description | Data |
|---|---|---|---|---|---|
| Yes | Ramp Width (in) | 48.0 | No | Ramp XSlope (%) | 8.3 |

**Remove & Replace Curb Ramp With Two New Directional Ramps or Equivalent.**

**R304.5.3**
