Access Compliance Report

Public Rights-of-Way

(Curb Ramps)

Intersection ID: 45499	Main Street: BUGGY_HORSE_RD	Cross Street: GRASSY_CROPS_RD	Location: W
ADA ID: EC547D51C6F5	Ramp Type: PerpDiag	Initial Pass/Fail: Fail	Overall Compliance: No
Severity Score: 42.5			
Codes/Mitigation Info/Possible Solution		Field Measurements/Component Compliance

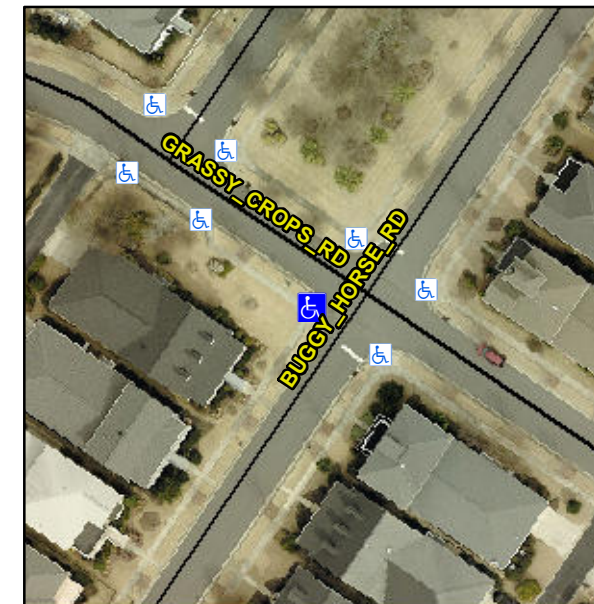
Not Found, R304.5.1, R304.2.2

Compliance	Description	Data	Compliance	Description	Data
N/A	Ramp Length (in)	71.0	No	Ramp Slope (%)	13.3
No	Ramp Width (in)	35.0	Yes	Ramp XSlope (%)	0.7
N/A	Flare Type LT	N/A	N/A	Flare Type RT	N/A
N/A	Flare Slope LT (%)	N/A	N/A	Flare Slope RT (%)	N/A
N/A	Flare Traversable LT?	N/A	N/A	Flare Traversable RT?	N/A
N/A	Landing Length (in)	N/A	N/A	DWS Provided?	N/A
N/A	Landing Width (in)	N/A	N/A	DWS Contrast?	N/A
N/A	Landing Slope (%)	N/A	N/A	DWS Length (in)	N/A
N/A	Landing X Slope (%)	N/A	N/A	DWS Full Width?	N/A
N/A	Landing Curb? (Y/N)	N/A	N/A	DWS Offset (in)	N/A
N/A	Shared Landing?	N/A			
N/A	Gutter Ponding?	N/A	N/A	Gutter Slope (%)	N/A
N/A	Gutter Lip Ht (in)	N/A	N/A	Gutter X Slope (%)	N/A
N/A	Painted X Walk1?	No	N/A	Painted X Walk2?	No
	X Walk 1 Direction	To SE		X Walk 2 Direction	To NE
N/A	X Walk 1 Width (in)	N/A	N/A	X Walk 2 Width (in)	N/A
	X Walk 1 Slope (%)	0.8		X Walk 2 Slope (%)	2.6
	X Walk 1 X Slope (%)	0.2		X Walk 2 X Slope (%)	0.7

N/A	Ramp inside XWalk1?	N/A	N/A	Ramp inside XWalk2?	N/A
	Road Slope (%)	0.6	N/A	Clear Space?	N/A
	Road X Slope (%)	1.0	N/A	Clear Space to XWalk (in)	N/A
N/A	Any Obstructions?	N/A	N/A	Storm Grate/Utility Hazard?	N/A
	Obstruction Type			Storm Grate/Utility Type	
		N/A			N/A
			Yes	Surface Condition? (G/P)	Good

Remove & Replace Curb Ramp With Two New Directional Ramps or Equivalent.
