Access Compliance Report

Public Rights-of-Way

Intersection ID: 10844	Main Street: W_5TH_ST	Cross Street: FRAZIER_AV	Location: N
ADA ID: EC583087478F	Ramp Type: PerpDiag	Initial Pass/Fail: Fail	Overall Compliance: No
Severity Score: 17.5			
Codes/Mitigation Info/Possible Solution		Field Measurements/Component Compliance

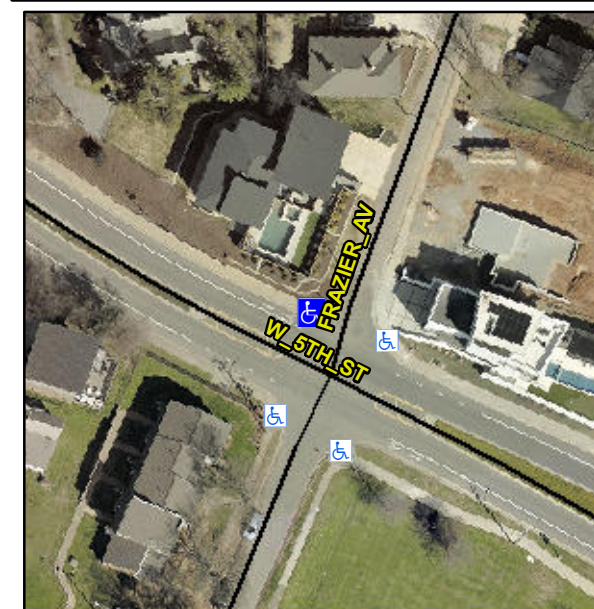
Compliance	Description	Data	Compliance	Description	Data
N/A	Ramp Length (in)	61.5	Yes	Ramp Slope (%)	8.1
No	Ramp Width (in)	33.0	Yes	Ramp XSlope (%)	0.3
N/A	Flare Type LT	N/A	N/A	Flare Type RT	N/A
N/A	Flare Slope LT (%)	N/A	N/A	Flare Slope RT (%)	N/A
N/A	Flare Traversable LT?	N/A	N/A	Flare Traversable RT?	N/A
N/A	Landing Length (in)	N/A	N/A	DWS Provided?	N/A
N/A	Landing Width (in)	N/A	N/A	DWS Contrast?	N/A
N/A	Landing Slope (%)	N/A	N/A	DWS Length (in)	N/A
N/A	Landing X Slope (%)	N/A	N/A	DWS Full Width?	N/A
N/A	Landing Curb? (Y/N)	N/A	N/A	DWS Offset (in)	N/A
N/A	Shared Landing?	N/A			
N/A	Gutter Ponding?	N/A	N/A	Gutter Slope (%)	N/A
N/A	Gutter Lip Ht (in)	N/A	N/A	Gutter X Slope (%)	N/A
N/A	Painted X Walk1?	No	N/A	Painted X Walk2?	No
	X Walk 1 Direction	To SW		X Walk 2 Direction	To SE
N/A	X Walk 1 Width (in)	N/A	N/A	X Walk 2 Width (in)	N/A
	X Walk 1 Slope (%)	2.4		X Walk 2 Slope (%)	8.1
	X Walk 1 X Slope (%)	5.0		X Walk 2 X Slope (%)	3.5

N/A	Ramp inside XWalk1?	N/A	N/A	Ramp inside XWalk2?	N/A
	Road Slope (%)	0.2	N/A	Clear Space?	N/A
	Road X Slope (%)	7.6	N/A	Clear Space to XWalk (in)	N/A
N/A	Any Obstructions?	N/A	N/A	Storm Grate/Utility Hazard?	N/A
	Obstruction Type			Storm Grate/Utility Type	
		N/A			N/A
		Yes		Surface Condition? (G/P)	Good

Possible Solutions:

Remove & Replace Curb Ramp With Two New Directional Ramps or Equivalent.

Not Found, R304.5.1
