Access Compliance Report

Public Rights-of-Way

(Curb Ramps)

Intersection ID: 20280	Main Street: CEDAR_HILL_DR	Cross Street: LARIX_DR	Location: NE
ADA ID: EC649E489993	Ramp Type: PerpDiag	Initial Pass/Fail: Fail	Overall Compliance: No
Severity Score: 13.75			
Codes/Mitigation Info/Possible Solution		Field Measurements/Component Compliance

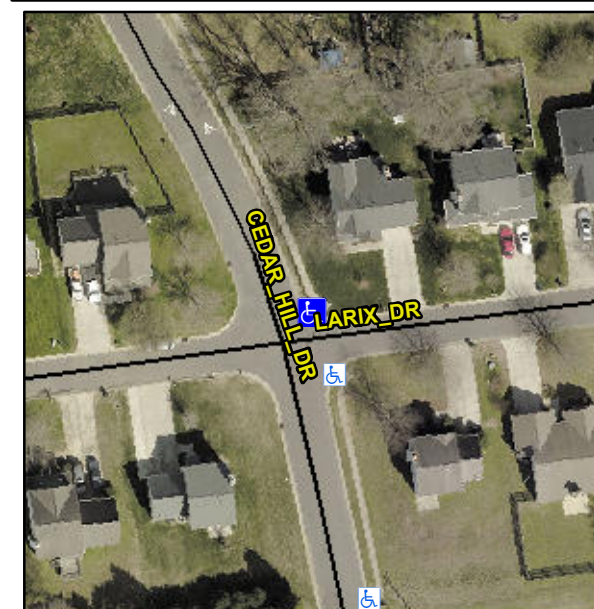
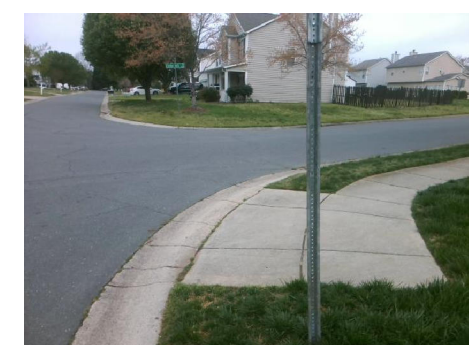
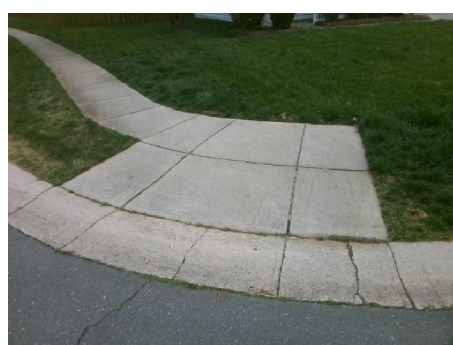
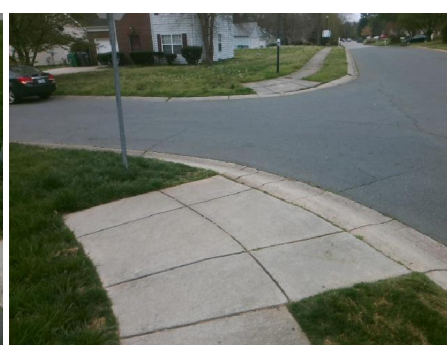
Compliance	Description	Data	Compliance	Description	Data
N/A	Ramp Length (in)	47.0	No	Ramp Slope (%)	8.9
Yes	Ramp Width (in)	52.0	No	Ramp XSlope (%)	3.1
N/A	Flare Type LT	N/A	N/A	Flare Type RT	N/A
N/A	Flare Slope LT (%)	N/A	N/A	Flare Slope RT (%)	N/A
N/A	Flare Traversable LT?	N/A	N/A	Flare Traversable RT?	N/A
N/A	Landing Length (in)	N/A	N/A	DWS Provided?	N/A
N/A	Landing Width (in)	N/A	N/A	DWS Contrast?	N/A
N/A	Landing Slope (%)	N/A	N/A	DWS Length (in)	N/A
N/A	Landing X Slope (%)	N/A	N/A	DWS Full Width?	N/A
N/A	Landing Curb? (Y/N)	N/A	N/A	DWS Offset (in)	N/A
N/A	Shared Landing?	N/A			
N/A	Gutter Ponding?	N/A	N/A	Gutter Slope (%)	N/A
N/A	Gutter Lip Ht (in)	N/A	N/A	Gutter X Slope (%)	N/A
N/A	Painted X Walk1?	No	N/A	Painted X Walk2?	No
	X Walk 1 Direction	To W		X Walk 2 Direction	To S
N/A	X Walk 1 Width (in)	N/A	N/A	X Walk 2 Width (in)	N/A
	X Walk 1 Slope (%)	6.9		X Walk 2 Slope (%)	3.7
	X Walk 1 X Slope (%)	0.1		X Walk 2 X Slope (%)	4.9

N/A	Ramp inside XWalk1?	N/A	N/A	Ramp inside XWalk2?	N/A
	Road Slope (%)	3.2	N/A	Clear Space?	N/A
	Road X Slope (%)	8.5	N/A	Clear Space to XWalk (in)	N/A
N/A	Any Obstructions?	N/A	N/A	Storm Grate/Utility Hazard?	N/A
	Obstruction Type			Storm Grate/Utility Type	
		N/A			N/A
		Yes		Surface Condition? (G/P)	Good

Possible Solutions:

Remove & Replace Curb Ramp With Two New Directional Ramps or Equivalent.

R304.2.2, R304.5.3
