Access Compliance Report

Public Rights-of-Way

(Curb Ramps)

Intersection ID: 9830	Main Street: ETHEL_GUEST_LN	Cross Street: GERALDINE_POWE_DR	Location: NW
ADA ID: EC8949720AE3	Ramp Type: PerpDiag	Initial Pass/Fail: Fail	Overall Compliance: No
Codes/Mitigation Info/Possible Solution		Field Measurements/Component Compliance	
Severity Score: 17.5

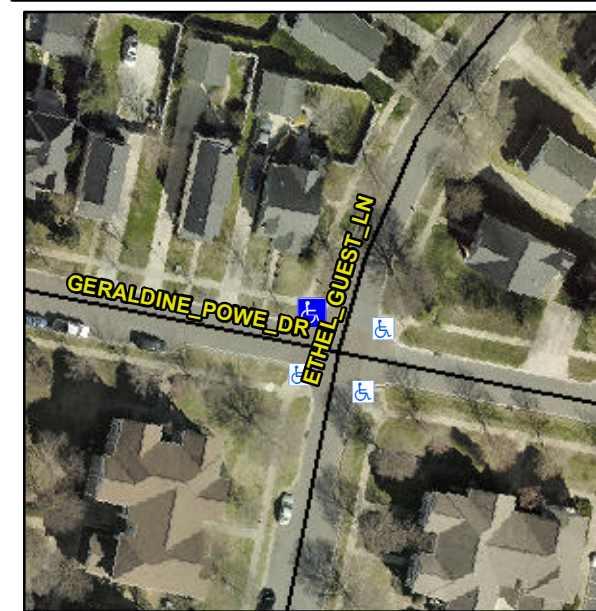
Not Found, R304.5.1

Compliance	Description	Data	Compliance	Description	Data
N/A	Ramp Length (in)	97.0	Yes	Ramp Slope (%)	6.2
No	Ramp Width (in)	32.5	Yes	Ramp XSlope (%)	0.9
N/A	Flare Type LT	N/A	N/A	Flare Type RT	N/A
N/A	Flare Slope LT (%)	N/A	N/A	Flare Slope RT (%)	N/A
N/A	Flare Traversable LT?	N/A	N/A	Flare Traversable RT?	N/A
N/A	Landing Length (in)	N/A	N/A	DWS Provided?	N/A
N/A	Landing Width (in)	N/A	N/A	DWS Contrast?	N/A
N/A	Landing Slope (%)	N/A	N/A	DWS Length (in)	N/A
N/A	Landing X Slope (%)	N/A	N/A	DWS Full Width?	N/A
N/A	Landing Curb? (Y/N)	N/A	N/A	DWS Offset (in)	N/A
N/A	Shared Landing?	N/A			
N/A	Gutter Ponding?	Yes	N/A	Gutter Slope (%)	N/A
N/A	Gutter Lip Ht (in)	0.5	N/A	Gutter X Slope (%)	N/A
N/A	Painted X Walk1?	No	N/A	Painted X Walk2?	No
	X Walk 1 Direction	To SW		X Walk 2 Direction	To SE
N/A	X Walk 1 Width (in)	N/A	N/A	X Walk 2 Width (in)	N/A
	X Walk 1 Slope (%)	3.9		X Walk 2 Slope (%)	2.3
	X Walk 1 X Slope (%)	1.1		X Walk 2 X Slope (%)	2.4

N/A	Ramp inside XWalk1?	N/A	N/A	Ramp inside XWalk2?	N/A
	Road Slope (%)	0.2	N/A	Clear Space?	N/A
	Road X Slope (%)	4.2	N/A	Clear Space to XWalk (in)	N/A
N/A	Any Obstructions?	N/A	N/A	Storm Grate/Utility Hazard?	N/A
	Obstruction Type			Storm Grate/Utility Type	
		N/A			N/A
		Yes		Surface Condition? (G/P)	Good

Remove & Replace Curb Ramp With Two New Directional Ramps or Equivalent.

Total Cost: \$ 3200.00
