Access Compliance Report

Public Rights-of-Way

(Curb Ramps)

Intersection ID: 42456	Main Street: SUNNINGHILL_PARK_RD	Cross Street: KINGSLEY_VIEW_DR	Location: NW
ADA ID: EC8D455DD6E0	Ramp Type: PerpDiag	Initial Pass/Fail: Fail	Overall Compliance: No
Severity Score: 58.75			
Codes/Mitigation Info/Possible Solution		Field Measurements/Component Compliance

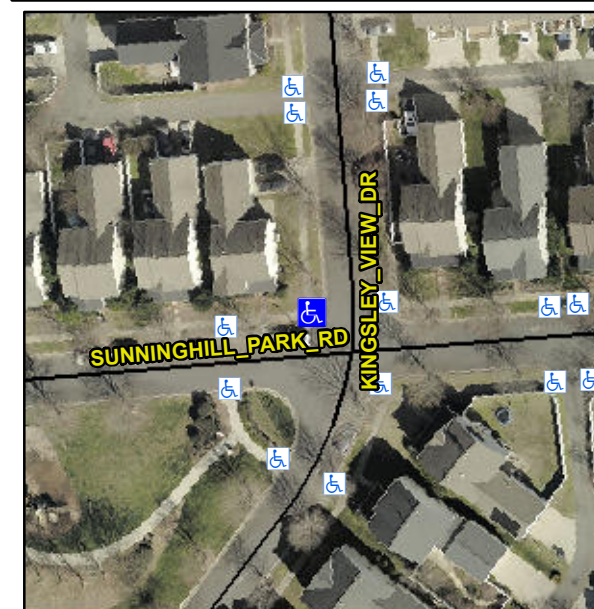
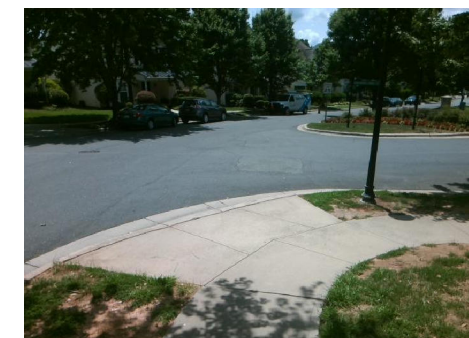
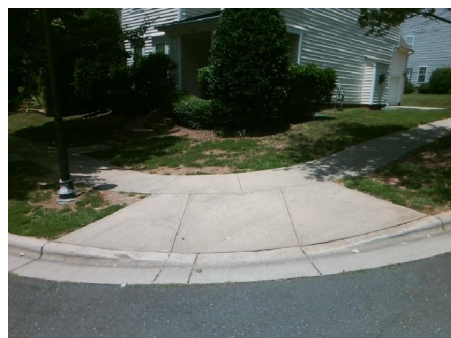
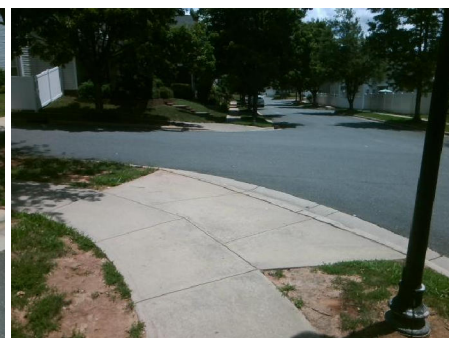
Not Found, R304.5.1, R304.2.2, R304.5.3

Compliance	Description	Data	Compliance	Description	Data
N/A	Ramp Length (in)	133.0	No	Ramp Slope (%)	12.0
No	Ramp Width (in)	46.0	No	Ramp XSlope (%)	10.4
N/A	Flare Type LT	N/A	N/A	Flare Type RT	N/A
N/A	Flare Slope LT (%)	N/A	N/A	Flare Slope RT (%)	N/A
N/A	Flare Traversable LT?	N/A	N/A	Flare Traversable RT?	N/A
N/A	Landing Length (in)	N/A	N/A	DWS Provided?	N/A
N/A	Landing Width (in)	N/A	N/A	DWS Contrast?	N/A
N/A	Landing Slope (%)	N/A	N/A	DWS Length (in)	N/A
N/A	Landing X Slope (%)	N/A	N/A	DWS Full Width?	N/A
N/A	Landing Curb? (Y/N)	N/A	N/A	DWS Offset (in)	N/A
N/A	Shared Landing?	N/A			
N/A	Gutter Ponding?	N/A	N/A	Gutter Slope (%)	N/A
N/A	Gutter Lip Ht (in)	N/A	N/A	Gutter X Slope (%)	N/A
N/A	Painted X Walk1?	No	N/A	Painted X Walk2?	No
	X Walk 1 Direction	To S		X Walk 2 Direction	To E
N/A	X Walk 1 Width (in)	N/A	N/A	X Walk 2 Width (in)	N/A
	X Walk 1 Slope (%)	3.1		X Walk 2 Slope (%)	3.9
	X Walk 1 X Slope (%)	5.5		X Walk 2 X Slope (%)	5.8

N/A	Ramp inside XWalk1?	N/A	N/A	Ramp inside XWalk2?	N/A
	Road Slope (%)	9.0	N/A	Clear Space?	N/A
	Road X Slope (%)	2.2	N/A	Clear Space to XWalk (in)	N/A
N/A	Any Obstructions?	N/A	N/A	Storm Grate/Utility Hazard?	N/A
	Obstruction Type			Storm Grate/Utility Type	
		N/A			N/A
			Yes	Surface Condition? (G/P)	Good

Remove & Replace Curb Ramp With Two New Directional Ramps or Equivalent.
