Access Compliance Report

Public Rights-of-Way

(Curb Ramps)

| Intersection ID: 42493 | Main Street: REA_RD | Cross Street: TOLLESON_AV | Location: NE |

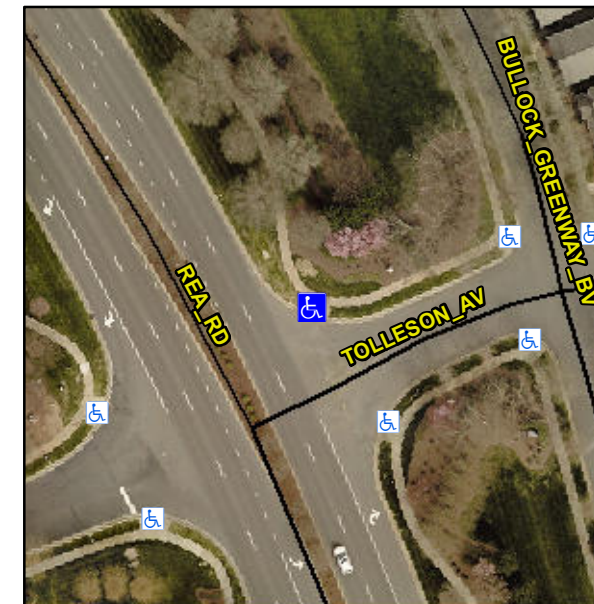
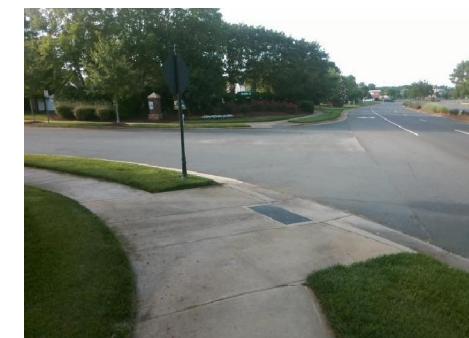
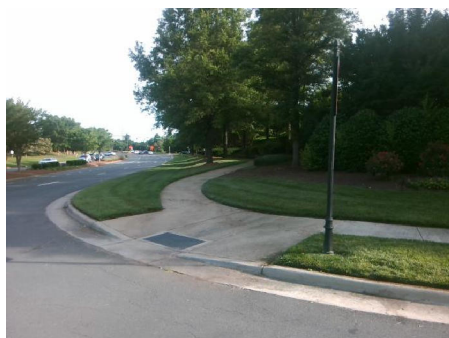
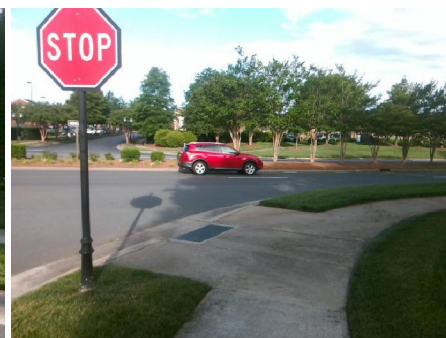
| ADA ID: EC8DE12C0848 | Ramp Type: Perp | Initial Pass/Fail: Fail | Overall Compliance: No |

R304.2.2

| Compliance | Description | Data | Compliance | Description | Data |
|---|---|---|---|---|---|
| N/A | Ramp Length (in) | 130.0 | No | Ramp Slope (%) | 10.5 |

Remove & Replace Entire Ramp.
