Access Compliance Report

Public Rights-of-Way

(Curb Ramps)

| Intersection ID: 12875 | Main Street: DOWNING_ST | Cross Street: ENFIELD_RD | Location: NW |

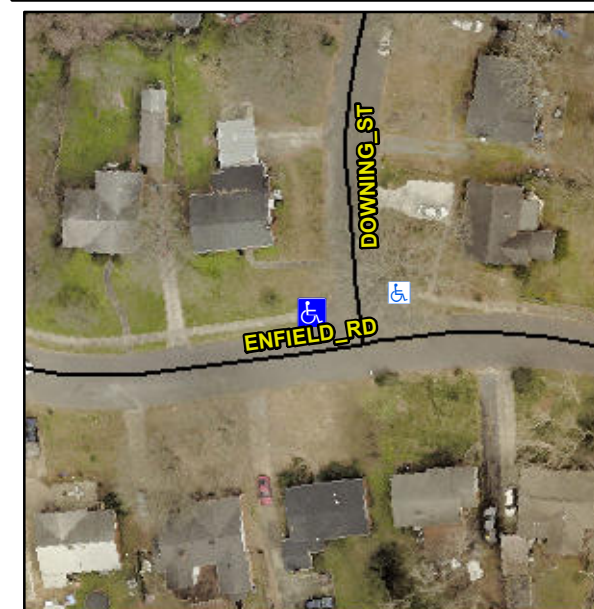
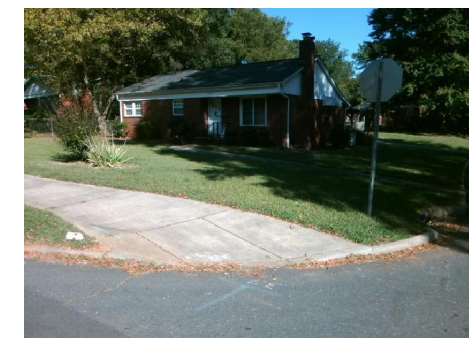
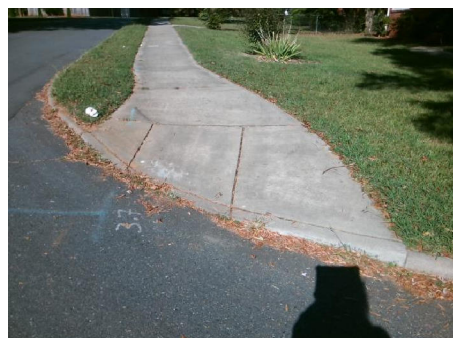
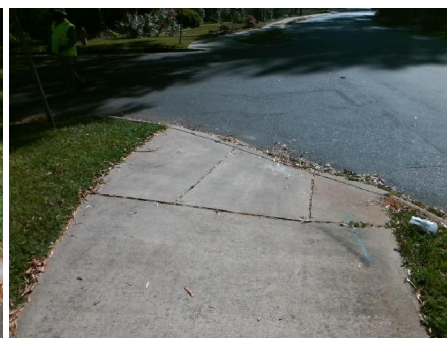
| ADA ID: EC967410E051 | Ramp Type: Perp | Initial Pass/Fail: Fail | Overall Compliance: No |

| Codes/Mitigation Info/Possible Solution | | | Severity Score: 35 |

Not Found, R304.5.1, R304.2.2, R304.5.3

| Compliance | Description | Data | Compliance | Description | Data |
|---|---|---|---|---|---|
| N/A | Ramp Length (in) | 45.0 | No | Ramp Slope (%) | 14.4 |
| No | Ramp Width (in) | 45.0 | No | Ramp XSlope (%) | 2.1 |

Possible Solutions:

Remove & Replace Entire Ramp.
