# Access Compliance Report

## Public Rights-of-Way

### (Curb Ramps)

Intersection ID: 50635	Main Street: RED_WATER_RD	Cross Street: BLUE_BLOSSOM_RD	Location: NW
ADA ID: ECA5F3741E5F	Ramp Type: Perp	Initial Pass/Fail: Fail	Overall Compliance: No
		Severity Score: 22.5

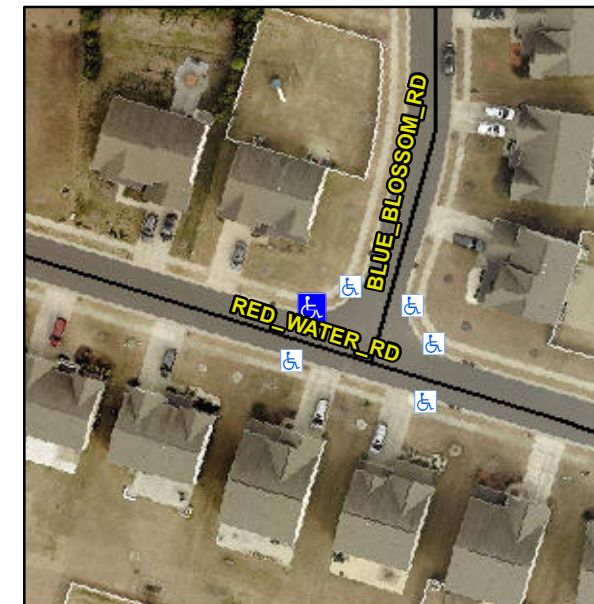
**Not Found, R304.5.1, R304.2.2, R304.5.3**

Compliance	Description	Data	Compliance	Description	Data
N/A	Ramp Length (in)	45.5	No	Ramp Slope (%)	10.2
No	Ramp Width (in)	47.0	No	Ramp XSlope (%)	2.9
N/A	Flare Type LT	N/A	N/A	Flare Type RT	N/A
N/A	Flare Slope LT (%)	N/A	N/A	Flare Slope RT (%)	N/A
N/A	Flare Traversable LT?	N/A	N/A	Flare Traversable RT?	N/A
N/A	Landing Length (in)	N/A	N/A	DWS Provided?	N/A
N/A	Landing Width (in)	N/A	N/A	DWS Contrast?	N/A
N/A	Landing Slope (%)	N/A	N/A	DWS Length (in)	N/A
N/A	Landing X Slope (%)	N/A	N/A	DWS Full Width?	N/A
N/A	Landing Curb? (Y/N)	N/A	N/A	DWS Offset (in)	N/A
N/A	Shared Landing?	N/A			
N/A	Gutter Ponding?	N/A	N/A	Gutter Slope (%)	N/A
N/A	Gutter Lip Ht (in)	N/A	N/A	Gutter X Slope (%)	N/A
N/A	Painted X Walk1?	No	N/A	Painted X Walk2?	N/A
	X Walk 1 Direction	To SW		X Walk 2 Direction	N/A
N/A	X Walk 1 Width (in)	N/A	N/A	X Walk 2 Width (in)	N/A
	X Walk 1 Slope (%)	2.0		X Walk 2 Slope (%)	N/A
	X Walk 1 X Slope (%)	2.7		X Walk 2 X Slope (%)	N/A

N/A	Ramp inside XWalk1?	N/A	N/A	Ramp inside XWalk2?	N/A
	Road Slope (%)	N/A	N/A	Clear Space?	N/A
	Road X Slope (%)	N/A	N/A	Clear Space to XWalk (in)	N/A
N/A	Any Obstructions?	N/A	N/A	Storm Grate/Utility Hazard?	N/A
	Obstruction Type			Storm Grate/Utility Type	
		N/A			N/A
			Yes	Surface Condition? (G/P)	Good

**Remove & Replace Entire Ramp.**
