Access Compliance Report

Public Rights-of-Way

(Curb Ramps)

Intersection ID: 20534	Main Street: CHARLTON_LN	Cross Street: FAIRVIEW_RD	Location: SW
ADA ID: ECC8DA2E009D	Ramp Type: PerpDiag	Initial Pass/Fail: Fail	Overall Compliance: No
			Severity Score: 21.25

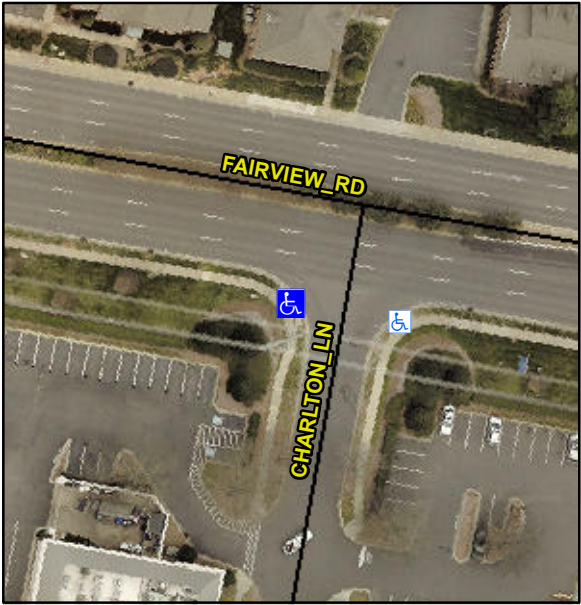
Possible Solutions:		Compliance	Description	Data
	Remove & Replace Curb Ramp With Two New Directional Ramps or Equivalent.		No	Ramp Length (in)	48.0
			No	Ramp Width (in)	42.0
			N/A	Flare Type LT	N/A
			N/A	Flare Slope LT (%)	N/A
			N/A	Flare Traversable LT?	N/A
			N/A	Landing Length (in)	N/A
			N/A	Landing Width (in)	N/A
			N/A	Landing Slope (%)	N/A
			N/A	Landing X Slope (%)	N/A
			N/A	Landing Curb? (Y/N)	N/A
			N/A	Shared Landing?	N/A
			N/A	Gutter Ponding?	N/A
			N/A	Gutter Lip Ht (in)	N/A
			N/A	Painted X Walk1?	No
				X Walk 1 Direction	To SE
			N/A	X Walk 1 Width (in)	N/A
				X Walk 1 Slope (%)	2.1
				X Walk 1 X Slope (%)	0.3
			N/A	Ramp inside XWalk1?	N/A
<p>Surveyor Notes:</p> <p>N/A</p> <p>PROW/ADA:</p> <p>Not Found, R304.5.1, R304.2.2</p>			N/A	Flare Type RT	N/A
			N/A	Flare Slope RT (%)	N/A
			N/A	Flare Traversable RT?	N/A

N/A	DWS Provided?	N/A
			N/A	DWS Contrast?	N/A
			N/A	DWS Length (in)	N/A
			N/A	DWS Full Width?	N/A
			N/A	DWS Offset (in)	N/A
			N/A	Gutter Slope (%)	N/A
			N/A	Gutter X Slope (%)	N/A
			N/A	Painted X Walk2?	No
				X Walk 2 Direction	To NE
			N/A	X Walk 2 Width (in)	N/A
				X Walk 2 Slope (%)	0.8
				X Walk 2 X Slope (%)	0.7
			N/A	Ramp inside XWalk2?	N/A
			N/A	Clear Space?	N/A
			N/A	Clear Space to XWalk (in)	N/A
			N/A	Storm Grate/Utility Hazard?	N/A
				Storm Grate/Utility Type	
			N/A		N/A
			Yes	Surface Condition? (G/P)	Good
Street 1 Name	CHARLTON LN				
Stop Condition-Street 2	StopSign				
Street 2 Name	FAIRVIEW RD				
Stop Condition-Street 1	None				
Total Cost:	\$	3200.00
