Access Compliance Report

Public Rights-of-Way

(Curb Ramps)

| Intersection ID: 28868 | Main Street: BIRDWELL_CT | Cross Street: SUTTONVIEW_DR | Location: S |

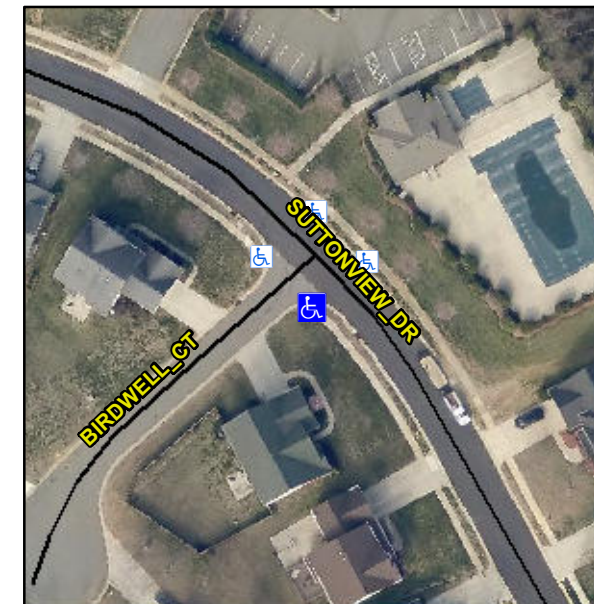
| ADA ID: ECDE48D5E658 | Ramp Type: PerpDiag | Initial Pass/Fail: Fail | Overall Compliance: No |
| Severity Score: 8.75 | | | |

Not Found, R304.5.1

| Compliance | Description | Data | Compliance | Description | Data |
|---|---|---|---|---|---|
| No | Ramp Width (in) | 39.0 | Yes | Ramp XSlope (%) | 1.9 |

Remove & Replace Curb Ramp With Two New Directional Ramps or Equivalent.
