Access Compliance Report Public Rights-of-Way (Curb Ramps)

Intersection ID: N/A Main Street: AMAY JAMES AV **Cross Street: LESTER ST** Location: NW Initial Pass/Fail: Fail **Overall Compliance: No Severity Score:** ADA ID: ECE3252433C9 Ramp Type: Combination2 37.5

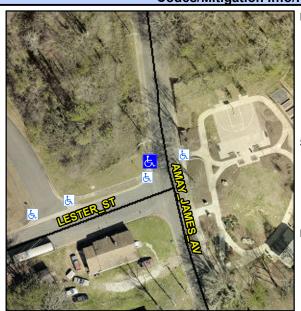
Street 1 Name None Stop Condition-Street 1 **AMAY JAMES AV** Street 2 Name N/A Stop Condition-Street 2 N/A Possible Solutions: Compliance Description Remove & Replace Entire Ramp. Surveyor Notes: N/A PROW/ADA: R304.3.2, R304.5.3
