Access Compliance Report Public Rights-of-Way (Curb Ramps)

Intersection ID: 17742 Main Street: S_WENDOVER_RD Cross Street: PROVIDENCE_RD Location: S

ADA ID: ECEC93647CD7 Ramp Type: PerpDiag Initial Pass/Fail: Fail Overall Compliance: No Severity Score: 13.75

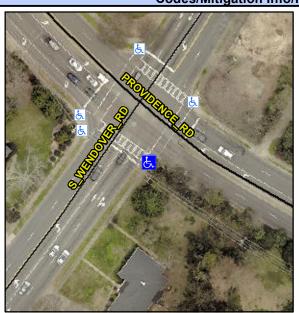
Not Found, R304.2.2, R304.5.3

Compliance Description Data Compliance Description Data No N/A Ramp Length (in) 55.5 Ramp Slope (%) 8.4 No Yes Ramp Width (in) 48.0 Ramp XSlope (%) 4.7 N/A N/A Flare Type LT N/A Flare Type RT N/A N/A N/A Flare Slope RT (%) N/A Flare Slope LT (%) N/A N/A Flare Traversable LT? N/A N/A Flare Traversable RT? N/A N/A N/A N/A DWS Provided? N/A Landing Length (in) N/A Landing Width (in) N/A N/A **DWS Contrast?** N/A N/A N/A N/A Landing Slope (%) DWS Length (in) N/A N/A Landing X Slope (%) N/A N/A DWS Full Width? N/A N/A Landing Curb? (Y/N) N/A N/A DWS Offset (in) N/A N/A N/A Shared Landing? N/A **Gutter Ponding?** N/A N/A Gutter Slope (%) N/A N/A Gutter Lip Ht (in) N/A N/A Gutter X Slope (%) N/A N/A Painted X Walk1? Yes N/A Painted X Walk2? Yes X Walk 1 Direction To NE X Walk 2 Direction To NW N/A 100.0 108.0 X Walk 1 Width (in) X Walk 2 Width (in) X Walk 1 Slope (%) 6.6 X Walk 2 Slope (%) 1.5 X Walk 2 X Slope (%) X Walk 1 X Slope (%) 1.7 5.1 N/A N/A Ramp inside XWalk2? Ramp inside XWalk1? Yes Yes Road Slope (%) 2.5 N/A Clear Space? N/A N/A Road X Slope (%) 6.4 Clear Space to XWalk (in) N/A N/A N/A Any Obstructions? N/A Storm Grate/Utility Hazard? N/A

Remove & Replace Curb Ramp With Two New Directional Ramps or Equivalent.
