# Access Compliance Report

## Public Rights-of-Way

### (Curb Ramps)

Intersection ID: 47455	Main Street: WOOD_DUCK_CROSSING_DR	Cross Street: PINTAIL_LANDING_LN	Location: NW
ADA ID: ECEF3F5F8E2D	Ramp Type: PerpDiag	Initial Pass/Fail: Fail	Overall Compliance: No
Severity Score: 8.75			
Codes/Mitigation Info/Possible Solution		Field Measurements/Component Compliance

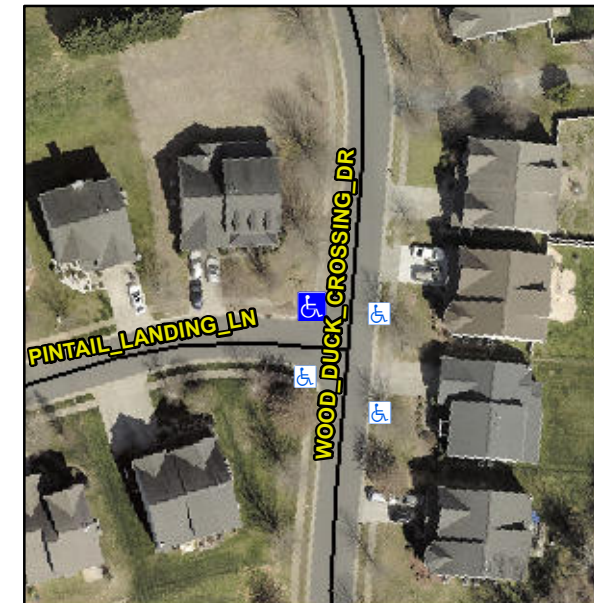
**Not Found, R304.5.1**

Compliance	Description	Data	Compliance	Description	Data
N/A	Ramp Length (in)	48.0	Yes	Ramp Slope (%)	7.9
No	Ramp Width (in)	47.0	Yes	Ramp XSlope (%)	1.1
N/A	Flare Type LT	N/A	N/A	Flare Type RT	N/A
N/A	Flare Slope LT (%)	N/A	N/A	Flare Slope RT (%)	N/A
N/A	Flare Traversable LT?	N/A	N/A	Flare Traversable RT?	N/A
N/A	Landing Length (in)	N/A	N/A	DWS Provided?	N/A
N/A	Landing Width (in)	N/A	N/A	DWS Contrast?	N/A
N/A	Landing Slope (%)	N/A	N/A	DWS Length (in)	N/A
N/A	Landing X Slope (%)	N/A	N/A	DWS Full Width?	N/A
N/A	Landing Curb? (Y/N)	N/A	N/A	DWS Offset (in)	N/A
N/A	Shared Landing?	N/A			
N/A	Gutter Ponding?	N/A	N/A	Gutter Slope (%)	N/A
N/A	Gutter Lip Ht (in)	N/A	N/A	Gutter X Slope (%)	N/A
N/A	Painted X Walk1?	No	N/A	Painted X Walk2?	No
	X Walk 1 Direction	To SW		X Walk 2 Direction	To SE
N/A	X Walk 1 Width (in)	N/A	N/A	X Walk 2 Width (in)	N/A
	X Walk 1 Slope (%)	1.0		X Walk 2 Slope (%)	3.6
	X Walk 1 X Slope (%)	1.7		X Walk 2 X Slope (%)	1.8

N/A	Ramp inside XWalk1?	N/A	N/A	Ramp inside XWalk2?	N/A
	Road Slope (%)	0.7	N/A	Clear Space?	N/A
	Road X Slope (%)	1.5	N/A	Clear Space to XWalk (in)	N/A
N/A	Any Obstructions?	N/A	N/A	Storm Grate/Utility Hazard?	N/A
	Obstruction Type			Storm Grate/Utility Type	
		N/A			N/A
			Yes	Surface Condition? (G/P)	Good

**Remove & Replace Curb Ramp With Two New Directional Ramps or Equivalent.**

Total Cost: \$ 3200.00
