Access Compliance Report

Public Rights-of-Way

(Curb Ramps)

Intersection ID: 53224	Main Street: URBAN_PL	Cross Street: GIVENS_WY	Location: SE
ADA ID: ED00EBB6AC5B	Ramp Type: PerpDiag	Initial Pass/Fail: Fail	Overall Compliance: No
		Severity Score: 22.5

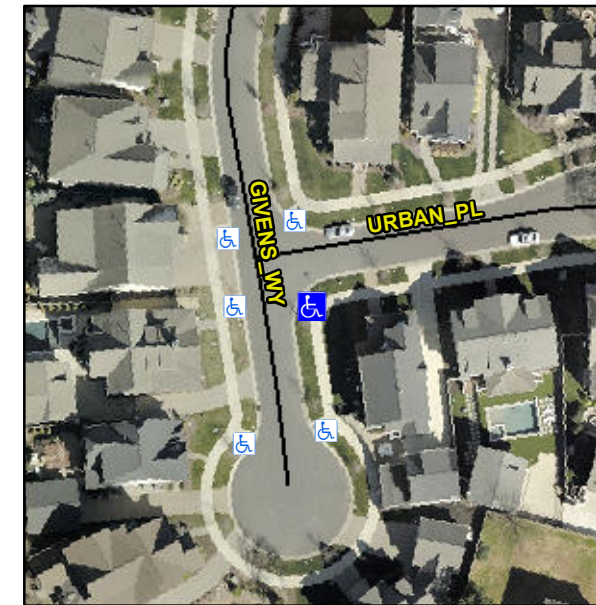
Not Found, R304.5.1, R304.2.2, R304.5.3

Compliance	Description	Data	Compliance	Description	Data
N/A	Ramp Length (in)	95.0	No	Ramp Slope (%)	9.4
No	Ramp Width (in)	40.5	No	Ramp XSlope (%)	2.6
N/A	Flare Type LT	N/A	N/A	Flare Type RT	N/A
N/A	Flare Slope LT (%)	N/A	N/A	Flare Slope RT (%)	N/A
N/A	Flare Traversable LT?	N/A	N/A	Flare Traversable RT?	N/A
N/A	Landing Length (in)	N/A	N/A	DWS Provided?	N/A
N/A	Landing Width (in)	N/A	N/A	DWS Contrast?	N/A
N/A	Landing Slope (%)	N/A	N/A	DWS Length (in)	N/A
N/A	Landing X Slope (%)	N/A	N/A	DWS Full Width?	N/A
N/A	Landing Curb? (Y/N)	N/A	N/A	DWS Offset (in)	N/A
N/A	Shared Landing?	N/A			
N/A	Gutter Ponding?	N/A	N/A	Gutter Slope (%)	N/A
N/A	Gutter Lip Ht (in)	N/A	N/A	Gutter X Slope (%)	N/A
N/A	Painted X Walk1?	No	N/A	Painted X Walk2?	No
	X Walk 1 Direction	To N		X Walk 2 Direction	To W
N/A	X Walk 1 Width (in)	N/A	N/A	X Walk 2 Width (in)	N/A
	X Walk 1 Slope (%)	2.3		X Walk 2 Slope (%)	2.7
	X Walk 1 X Slope (%)	1.0		X Walk 2 X Slope (%)	3.1

Remove & Replace Curb Ramp With Two New Directional Ramps or Equivalent.
